### Scope

This bulletin clarifies the reasons for excessive vertical and horizontal movement between the fifth wheel top plate and fixed mounting bracket or slider mounting bracket (saddle). It will help determine the correct thickness bracket pad required and define corrective maintenance for excessive vertical and horizontal movement at the bracket connection.

# SIMPLEX® Bracket Connection Inspection

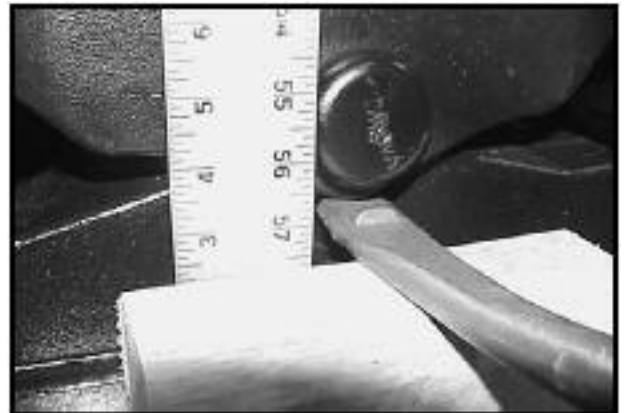
*Figure 1*

The bracket pads should be replaced when the clearance between the fifth wheel top plate and mounting bracket exceeds 5/16" vertical or 3/8" horizontal movement.

The vertical movement can be measured (see *Figure 1*) by prying up on the top plate and measuring the movement in the bracket connection.

When measuring the top plate vertical lift on a slider, make sure to isolate the top plate and not include any lift from the saddle plate in the slider's rail segments.

When excessive vertical or horizontal movement is present, it is recommended that the bracket pads be replaced with the correct thickness pads, per the table. At the time the bracket pads are replaced, the bracket pins should be inspected for wear. Both bracket pins should be replaced if either one of them has worn 1/8" from the 1.5" original size. It is also recommended that the polyurethane bracket shoes be inspected for any signs of damage or wear. Replace as needed.
