Service Bulletin Height Control Valve

CBXA40 Height Control Valve Upper Bracket Position

October 2017

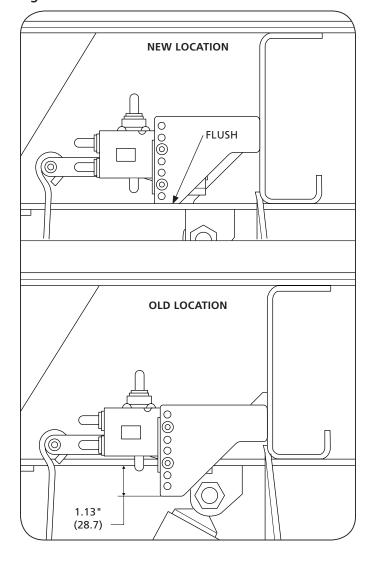
Figure 1

CBXA40 built between the dates of September 1st 2017 thru October 4th 2017 may have the HCV bracket installed improperly. Units affected may have ride height set lower than intended. SAF-HOLLAND® has developed the following instruction to address these units.

Determine the location of the height control valve (HCV) upper bracket (Figure 1).

■ If the HCV bracket is located 1.13" below the slide box frame rail (OLD LOCATION), no revision to the ride height should be necessary. Use the chart below to determine the appropriate HCV position based on ride height (Table 1 and Figure 2).

- If the HCV bracket is located flush with the slide box frame rail (NEW LOCATION), proceed to next step below.
- Replace 15" HCV double loop link with 16" HCV double loop link (SAF-HOLLAND Part Number 90560125).
- Reposition the HCV using Table 2 and Figure 3.
- With the HCV in the new location and the 16" double loop link installed check the ride height and make adjustments to be within ±0.25" (Figure 4).
