EZ-ALIGN SERVICE BULLETIN SERVICEABILITY

Trailer Air Suspensions

EZ-Align Identification - Old Style vs. New Style

January 21, 2002

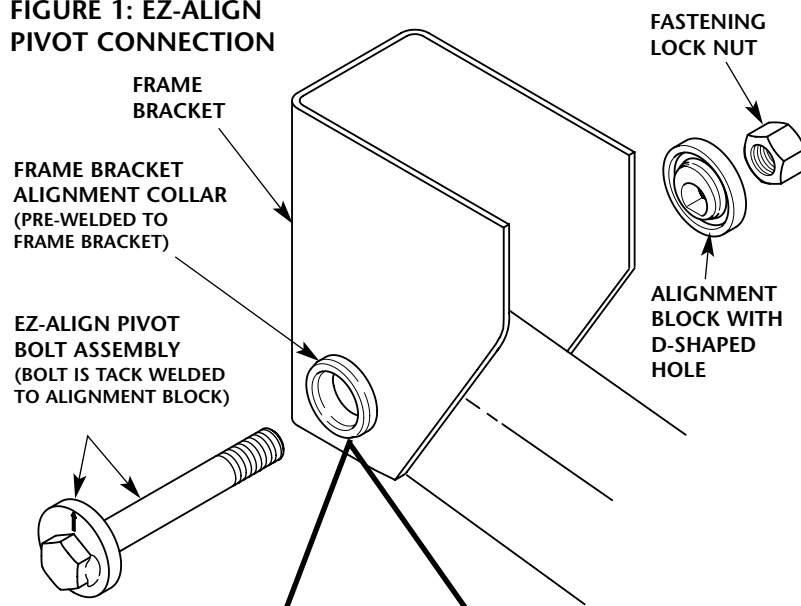
FIGURE 1: EZ-ALIGN PIVOT CONNECTION

1. Visually check the alignment block/hex bolt assembly, alignment block and the frame bracket collars to identify the EZ-Align connection as either old or new style (FIG. 1, 1A & 1B).

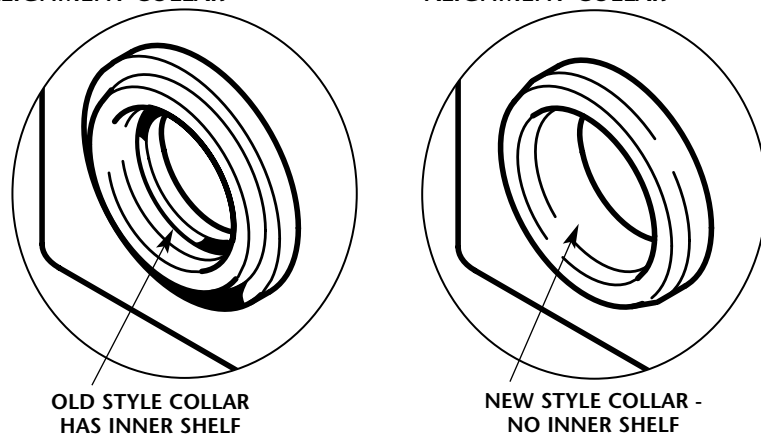
The old style frame bracket collar can be identified by an inner shelf inside the collar. This inner shelf will not allow the new style alignment blocks or alignment block/hex bolt assembly to mate properly (FIG. 1A & 4). The old style alignment block and alignment block/hex bolt assembly are shown in Figure 2, page 2.

The new style frame bracket alignment collars do not have an inner shelf (FIG. 1B). The new style alignment block and alignment block/hex bolt assembly are shown in Figure 3, page 2. New style can be identified by a protrusion nose on the inside surface (FIG. 3) the old style alignment blocks **DO NOT** have this nose (FIG.2).

FIGURE 1A:
OLD STYLE FRAME BRACKET ALIGNMENT COLLAR

FIGURE 1B:
NEW STYLE FRAME BRACKET ALIGNMENT COLLAR

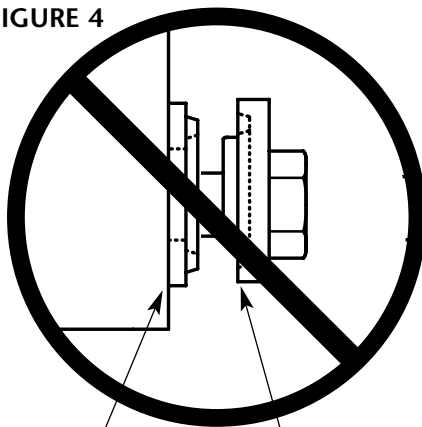
FIGURE 4

Using new style EZ-Align alignment blocks or alignment block/hex bolt assembly with old style EZ-Align frame bracket alignment collars could allow the pivot connection to loosen. A loose pivot connection could cause damaged bushings and/or pivot bolts leading to suspension and/or trailer damage and potential loss of vehicle control.

DO NOT use new style EZ-Align alignment blocks or alignment block/hex bolt assembly with old style EZ-Align frame bracket alignment collars. They will not mate properly (FIG. 4).

OLD STYLE FRAME BRACKET ALIGNMENT COLLARS

NEW STYLE EZ-ALIGN PIVOT BOLT ASSEMBLY
