COUPLER PRODUCTS

SAFETY RECALL SERVICE BULLETIN

Draft hook retaining nut recall (NHTSA recall No. 02E-041) for CP-400-H and CP-400-CA

July 8, 2002

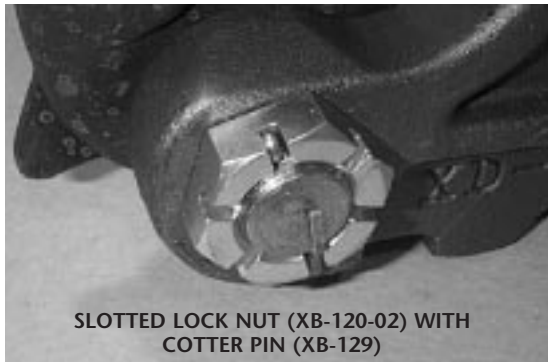
FIGURE 1 No change necessary

If the coupler has a draft hook retaining nut that looks like the nut shown in **FIGURE 1**, the coupler is **NOT** subject to this recall and you do **NOT** need to make any changes to the coupler.

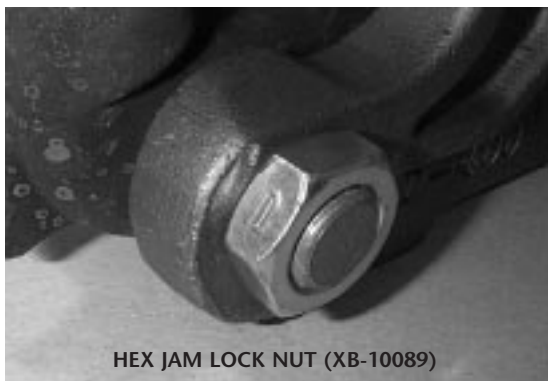
FIGURE 2 Change is necessary

Model CP-400-H and CP-400-CA couplers manufactured between July 18, 2001 and June 18, 2002 were assembled with a hex jam lock nut (XB-10089), see **FIGURE 2** on page 2, which replaced a slotted hex nut (XB-120-2) and retaining cotter pin (XB-129), see **FIGURE 1** on page 2.

Reportedly, the hex jam lock nut may become loose during shipment, or—over time—it may rotate off the bolt. This may occur, during normal use, because of vibration or the dynamic interaction between the draft hook and the towed trailer's drawbar.

If the nut completely unfastens from the hook bolt, the bolt can fall out and the draft hook can detach from the coupler frame. This may allow the drawbar of a towed trailer to uncouple from the coupler frame. At that point, only the required safety chains will secure the trailer to the tow vehicle.

If your coupler has a draft hook retaining nut that looks like the nut shown in **FIGURE 2**, your coupler **IS** subject to this recall and you **MUST** replace the nut according to the procedure outlined in this service bulletin.

1. Remove the existing nut (XB-10089) (shown in **FIGURE 2**).
2. Replace it with the top lock nut (XB-04473) available from Holland free of charge, (see **FIGURE 4** for what it should look like).

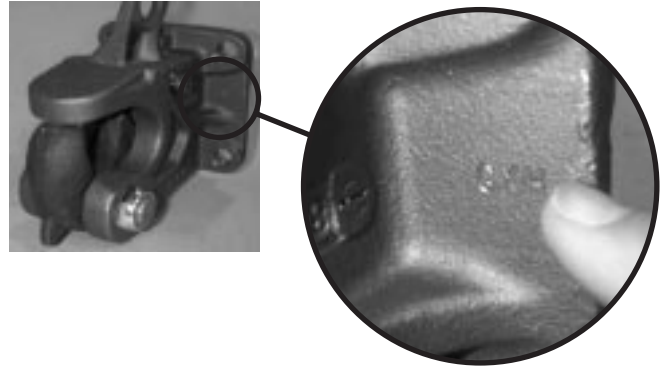
FIGURE 3 Manufacturing Date Code location

If the coupler has a manufacturing date code listed below (**CHART A**), the coupler **IS** subject to this recall and you **MUST** replace the nut according to the procedure outlined in this service bulletin.

The manufacturing date code is located as shown in **FIGURE 3**.
