Service Bulletin - June 2023

SAF Tire Pilot Plus™ (TPP) Inflation System

Tire Pilot Plus Safety Concern

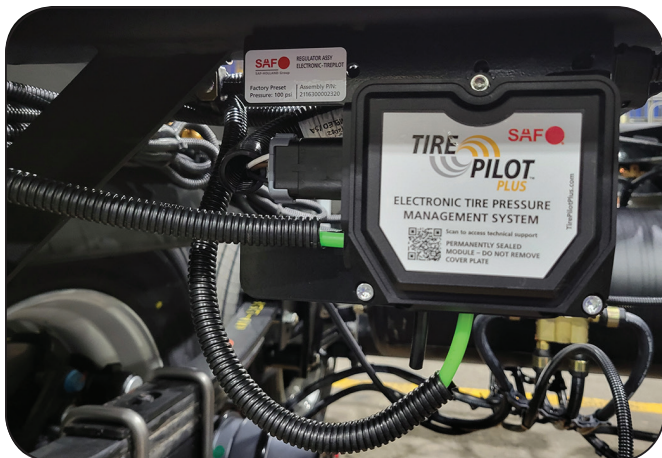
Figure 1

1. Check the trailer build date on the VIN tag. If it was manufactured between November 2022 and January 2024, the trailer could be in the target group, but needs to be confirmed to have the electronic regulator assembly installed.
2. The electronic regulator (ECU) to be disabled is likely located on the front cross-member for a sliding suspension and on the main trailer beam for a fixed suspension. If the color of the ECU label is white (**Figure 1**), proceed with the disable procedure. If the ECU label has a yellow background (**Figure 2**) and the tire hoses have a yellow wrap, the disable procedure is not required.
3. Before performing any maintenance on the trailer, set the parking brake and block the tires.
