Service Bulletin - June 2023

SAF Tire Pilot Plus™ (TPP) Inflation System

Hubcap Window Replacement

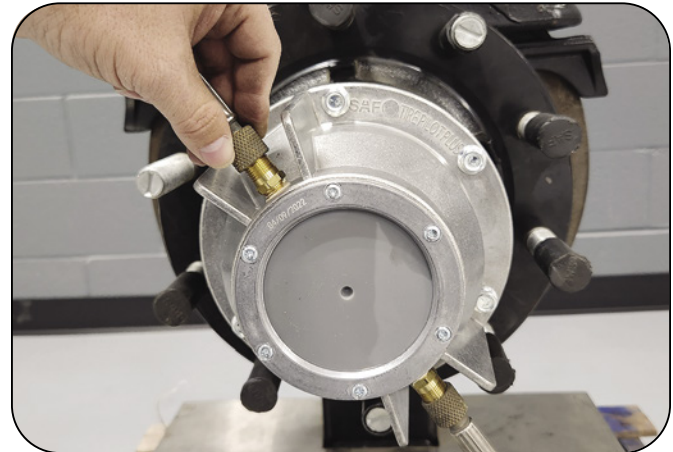
Figure 2

Tire Pilot Plus (TPP) grease style hubcaps on axles produced after January 2020 through May 2023 (date code 20 001 through 23 150) may have been manufactured with non-conforming hubcap window material. This can result in failure of the hubcap window, exposing the wheel end to the environment. We recommend replacing these windows at the next service interval or if a failure occurs. All hubcaps windows on a single trailer should be replaced at the same time. Replacement window kit part number is 48100816. Each kit contains 4 window replacements.

- Check date code range, on the axle serial tag, to see if it falls inside the affected date range, date codes 20 001 and up. (**Figure 1**).
- Figure 2** illustrates the grease style plastic hubcap window that will need to be replaced.
- Figure 3** illustrates the aluminum replacement hubcap window with duck-bill vent.
