WARNING - Unauthorized Hazardous Brake Pads in Circulation

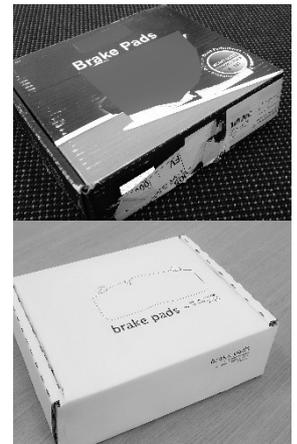
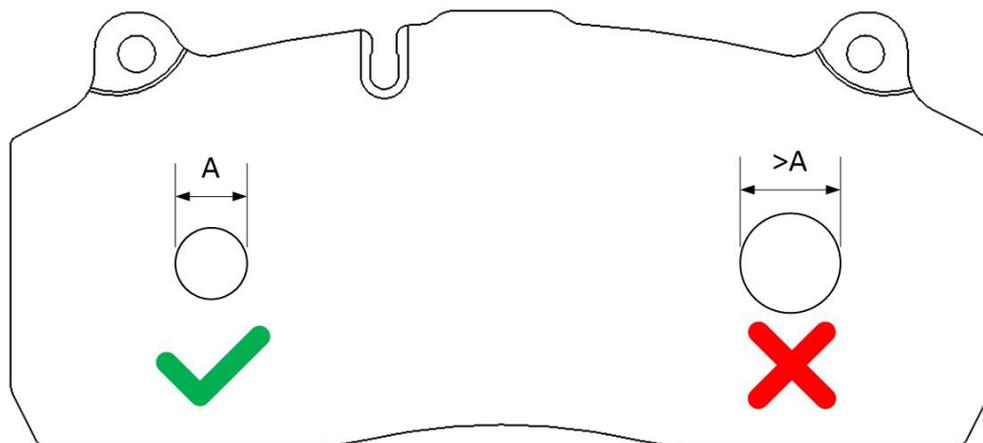
Unauthorized spare part brake pads for the disc brake SBS2220H0 (Haldex DBT 22 LT) from SAF-HOLLAND have been found in the market. These copies have larger holes in the back plate of the brake pads, see Fig. 1 below, and do not provide the required amount of support to the projections on the thrust plate and whole mechanism as original SAF-HOLLAND spare parts.

Fig. 1: A brake pad for the SBS2220H0 (Haldex DBT 22 LT) air disc brake is shown above. In the brake pad, the standard hole size is depicted to the left, and the enlarged hole is shown to the right.

SAF SBS2220H0 (Haldex DBT 22 LT) disc brakes equipped with unauthorized brake pads have in tests shown the acceleration of the thrust plate to be significantly higher, and have been found in failed brakes having broken follower pins. This can cause the disc brake to lose the ability to brake! If non-validated spare parts are fitted, this not only invalidates any product warranty but also jeopardises the safe operational function of the brake. If you have any questions do not hesitate to contact the SAF-HOLLAND Aftermarket Support under +49 (0) 6095-301-301.

Do not hesitate to contact SAF-HOLLAND should you be concerned about this issue or require further information. SAF-HOLLAND can also assist to ensure your vehicles are fitted with the correctly validated spare parts to ensure continual safe brake function operation.
