Service Manual

INTEGRAL[®] Disc Brake Axles

P89 Parallel Spindle with Precision Bearings

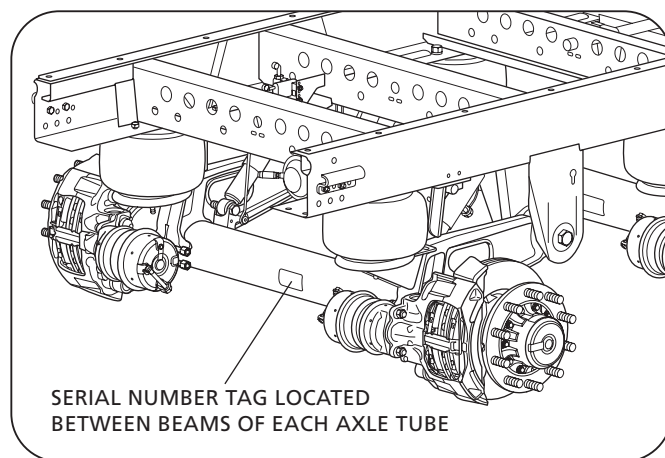
Figure 1

The disc brake axle serial tag is located near the center of the axle tube (**Figure 1**).

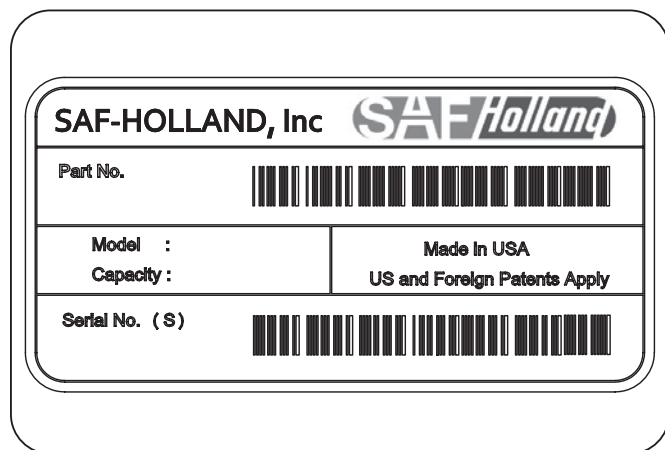
Figure 2

The sample tag shown will help you interpret the information on the SAF-HOLLAND Inc. serial number tag. The model number, axle body part number and serial number are listed on the tag (**Figure 2**).

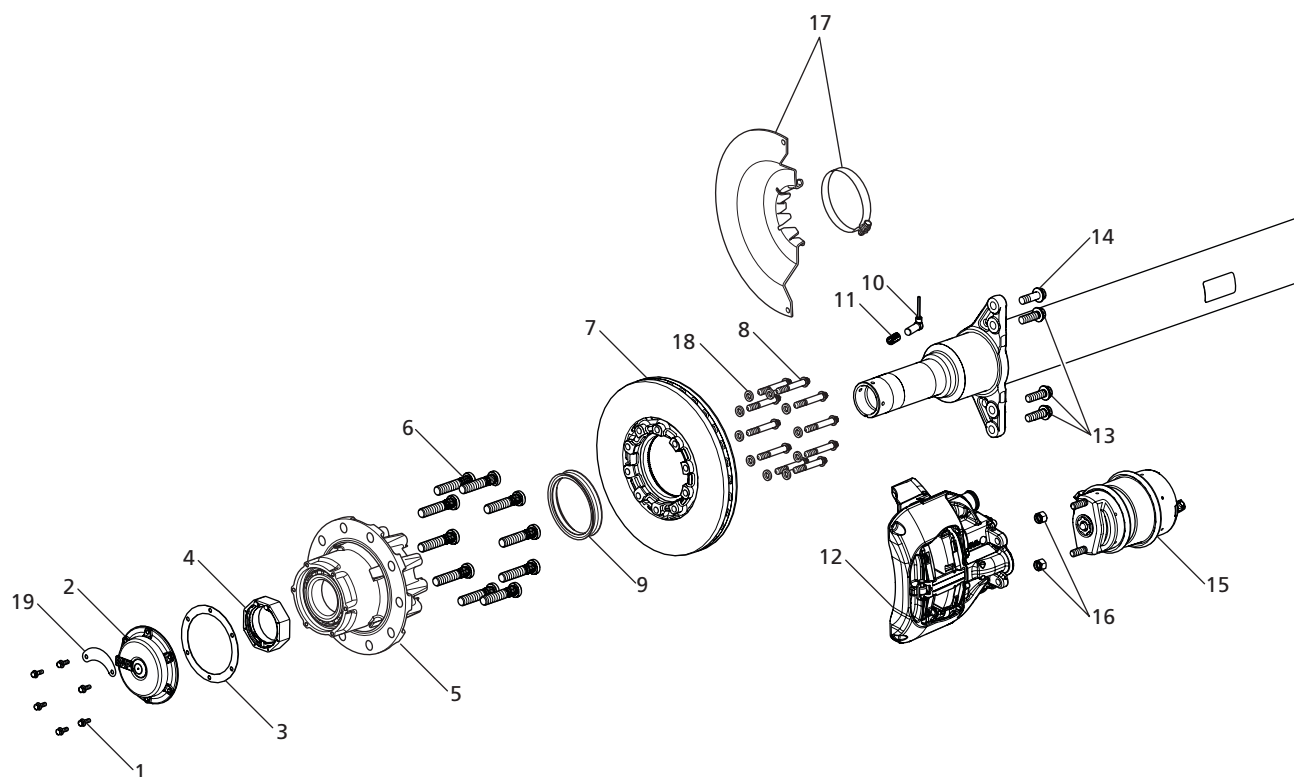
ITEM	DESCRIPTION	QTY. / AXLE
1	Bolt, Hub Cap	12
2	Hub Cap	2
3	Gasket, Hub Cap	2
4	Nut, One Piece Axle	2
5	Hub with Bearings	2
6	Wheel Studs	20
7	Rotor with ABS Tone Ring	2
8	Rotor Attachment Bolts	20
9	Seal, Hub	2
10	ABS Sensor (WABCO)	2

ITEM	DESCRIPTION	QTY. / AXLE
11	Clamping Bush	2
12	Brake Caliper Left-Hand Brake Caliper Right-Hand	1
13	M18 x 1.5" Bolt, Standard	6
14	M18 x 1.5" Bolt, Shoulder	2
15	Brake Chamber	2
16	Brake Chamber nut	4
17	Dust Shield with Clamp (optional)	2
18	Washers	20
19	P89 Identification Tag	1

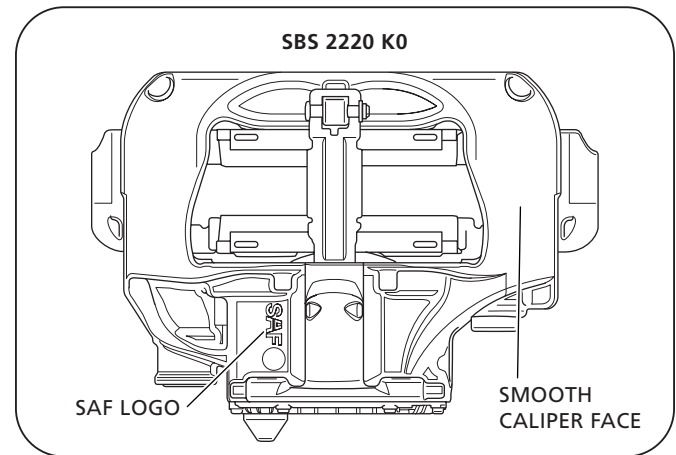
Figure 3

The SAF-HOLLAND SBS 2220 K0 has a smooth forward face of the caliper and SAF logo on the rear side (**Figure 3**).

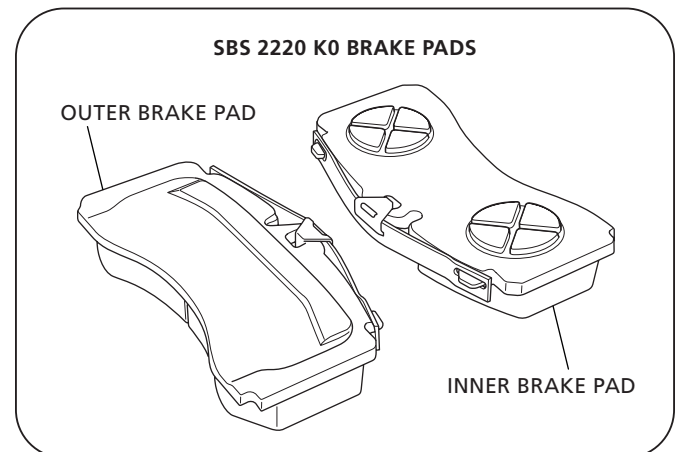
Figure 4

The inner and outer brake pads for the SBS 2220 K0 are different in shape. The inner brake pad has two “circle X’s” on the back side, while the outer brake pad has a relatively smooth back. There is also a notch on the pads to keep them from being installed in the wrong position (**Figure 4**).

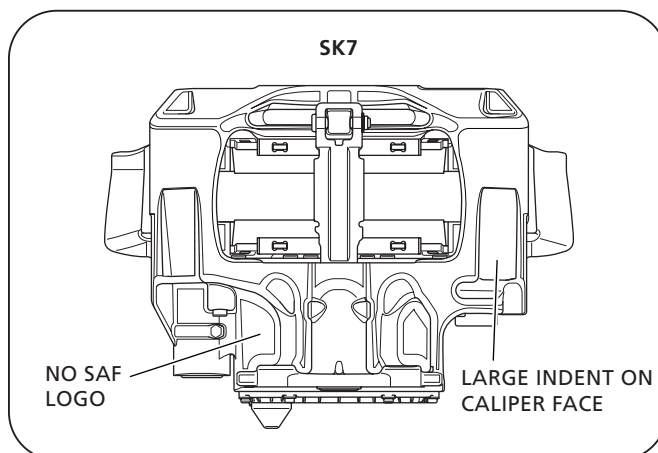
Figure 5

The Knorr-Bremse SK7 Caliper has a large indentation on the forward face and no SAF logo on the rear of the caliper (**Figure 5**).

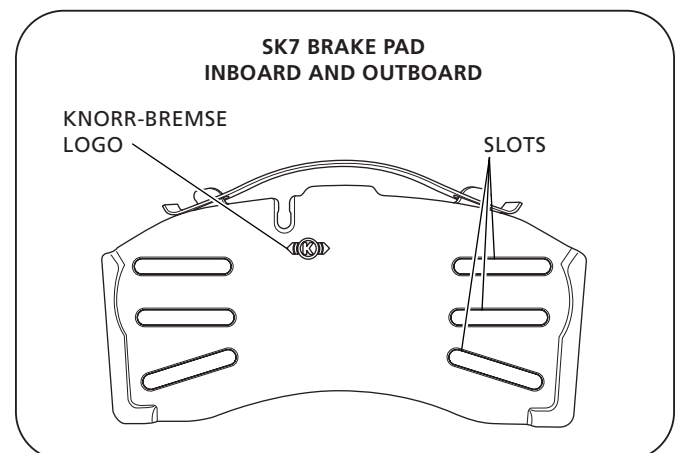
Figure 6

The brake pads in the SK7 caliper are the same for the inner and outer side of the caliper. The back of the brake pad has the Knorr-Bremse logo and six (6) slots on the back of the brake pad (**Figure 6**).

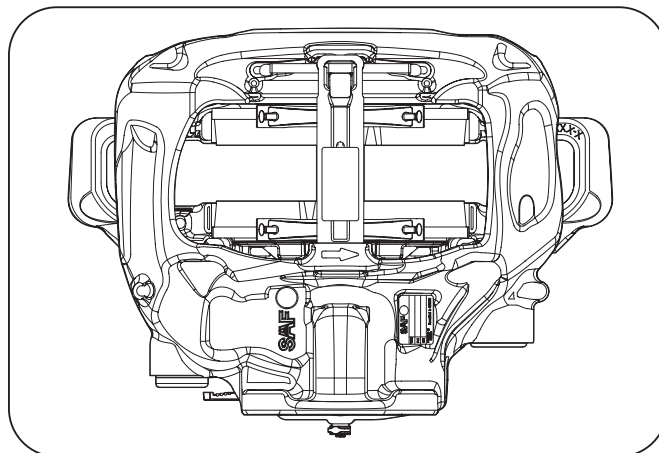
Figure 7

The SAF-HOLLAND SBS 2220 H20 caliper has an SAF logo on the rear side (**Figure 7**). The calipers brake pad retainer bar is held in place by a spring clip similar to the brake pads (it has no pins or bolts).

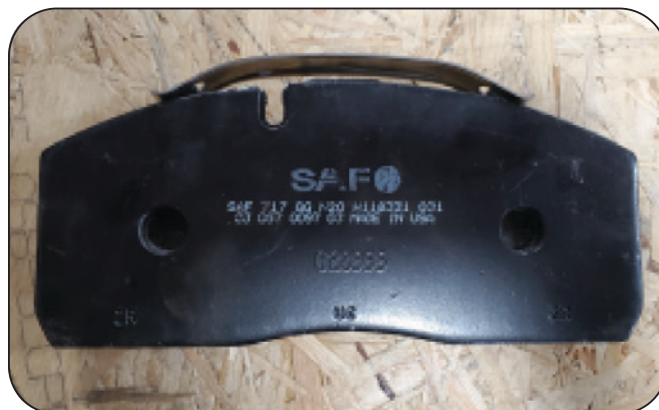
Figure 8

The brake pads in the SBS 2220 H20 caliper are the same for the inner and outer side of the caliper. The back of the brake pad has the SAF logo and two (2) indentations on the back of the pad that align with the caliper piston locators (**Figure 8**).

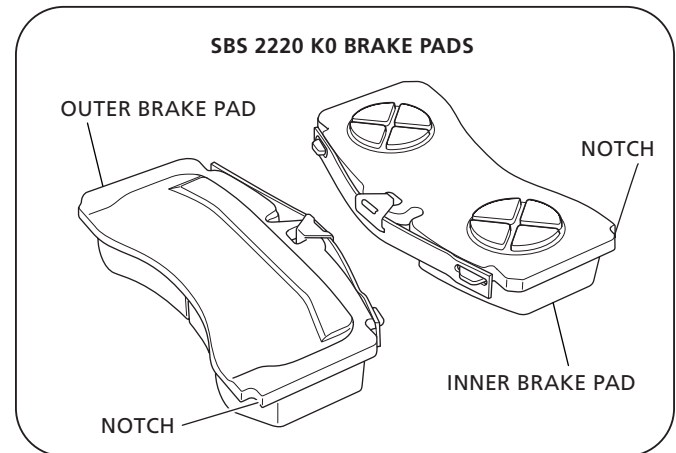
Figure 9

The inner and outer brake pads for the SBS 2220 KO are different in shape. The inner brake pad has two "circle X's" on the back side, while the outer brake pad has a relatively smooth back. There is also a notch on the pads to keep them from being installed in the wrong position (**Figure 9**).

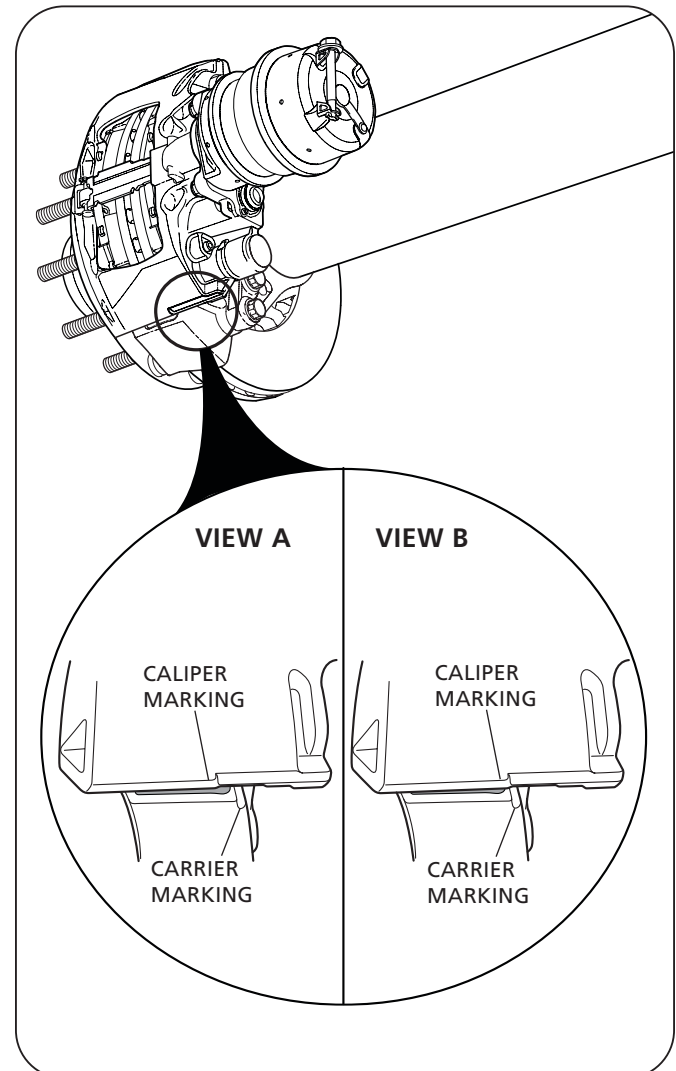
Figure 10

1. Compare the position of the caliper marking to the carrier marking located on the underside of the caliper unit (**Figure 10**).
 - a. **Figure 10** - "View A" shows the positions of the two (2) markings when the brake pads are in good condition.
 - b. **Figure 10** - "View B" shows the positions of the two (2) markings when the wheel **MUST** be removed for further inspection of wear to the brake pads and brake rotor.

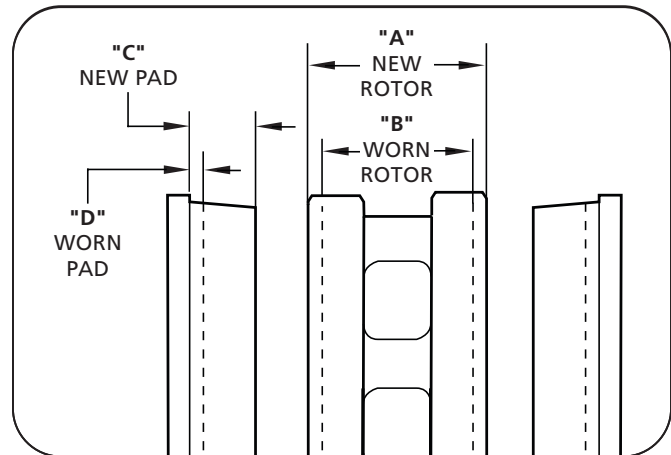
Figure 11

If the friction material of the brake pad is less than 0.080" (2 mm) at its thinnest area, the brake pad **MUST** be replaced (**Figure 11**).

If the overall wear limits for the brake rotor and brake pads are exceeded (**Figure 11**), the rotor and pads **MUST** be replaced. Refer to brake pad and rotor replacement instructions as detailed in Sections 8.1 and 8.4 respectively.

BRAKE ROTOR			BRAKE PAD	
DIAMETER	"A" NEW	"B" WEAR LIMIT	"C" NEW	"D" WEAR LIMIT
430 mm	45 mm	37 mm	23 mm	2 mm
16.93"	1.77"	1.46"	0.9"	0.080"

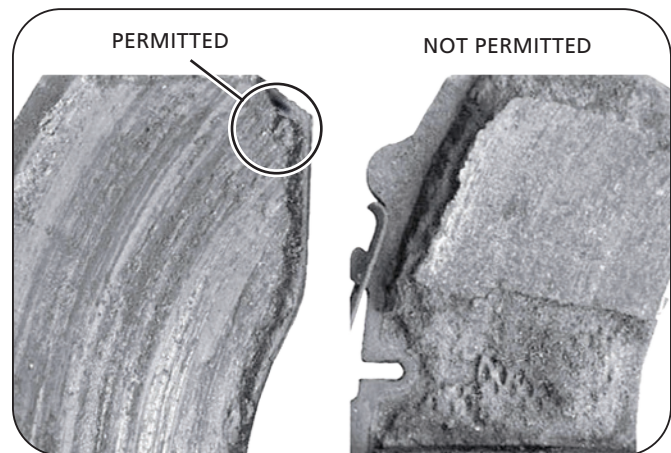
Figure 12

NOTE: Minor breakouts at the edges are permitted; major breakouts on the surface of the brake pad are **NOT** permitted (**Figure 12**).

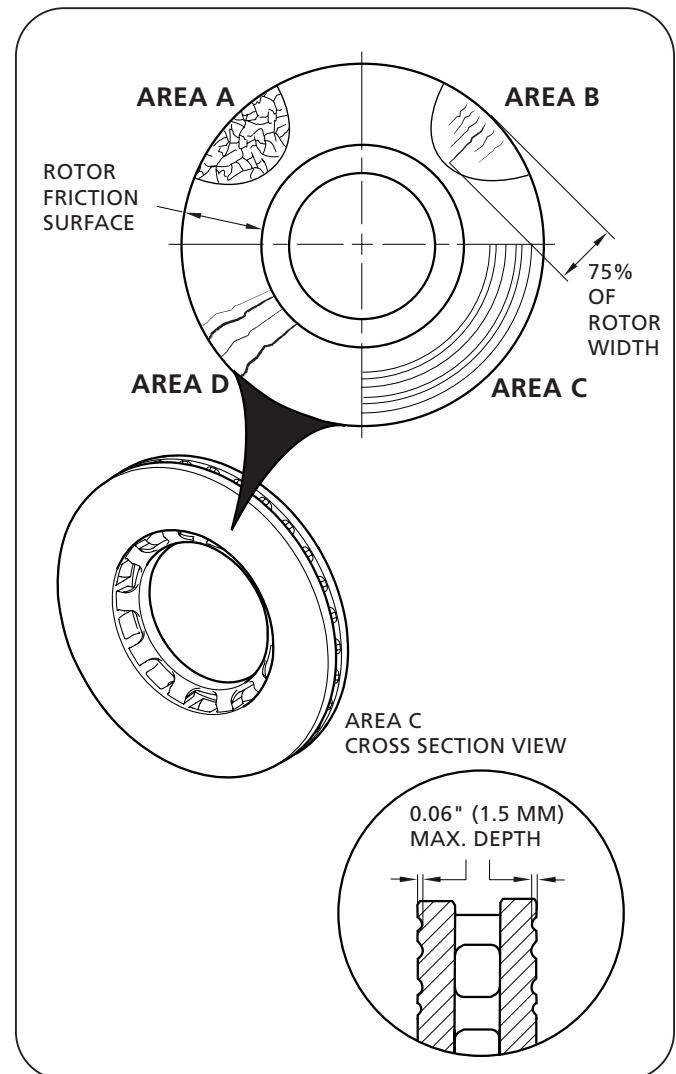
Figure 13

1. Carefully inspect both sides of the brake rotor friction surface (**Figure 13**).
 - a. Spider web cracking is acceptable (**Area A**).
 - b. Radial cracks less than 0.06" (1.5 mm) deep or wide and their length is less than 75% of the width of the rotor friction surface are acceptable (**Area B**).
 - c. Grooves in the rotor surface are acceptable only if they are less than 0.06" (1.5 mm) deep (**Area C**).
 - d. Cracks that run completely to either edge of the hub are **NOT** acceptable, regardless of depth (**Area D**).
2. Measure the brake rotor thickness and re-surface, if necessary. For proper brake function, the minimum thickness for re-surfacing the brake rotor is defined as 1.54-1.57" (39-40 mm).

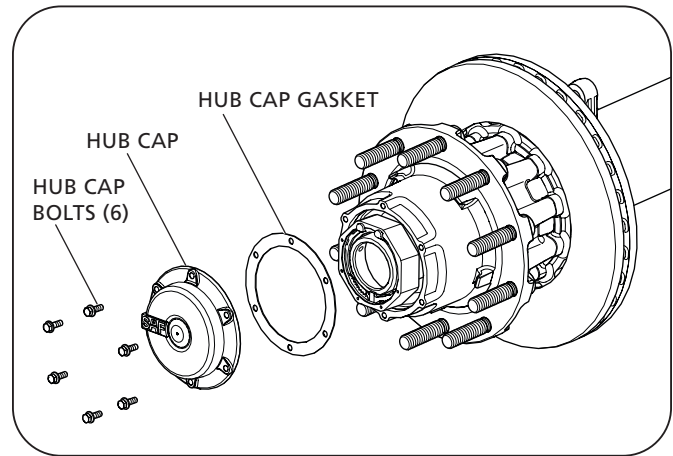
Figure 14

1. For sufficient clearance to perform the test, raise the wheel off the ground. DO NOT remove the wheel.
2. With a 1/2" socket, remove the six (6) hub cap bolts and the hub cap (**Figure 14**).
3. Utilizing a screwdriver, carefully pry the orange keeper arm from the undercut groove on each side of the one piece axle nut until the keeper is released from it (**Figure 15**).
4. Using a standard 4-13/16" P-Spindle wheel nut socket, check the torque of the axle nut to ensure that it is torqued to 500 ft-lbs (680 N•m) by rotating the nut in a clockwise direction (**Figure 15**).
5. Re-install the orange keeper arm.

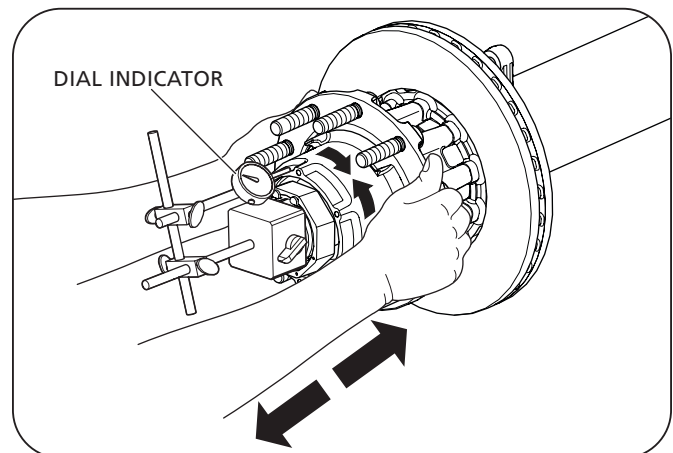
Figure 16

6. Clean the face of the spindle. Attach the magnetic foot of the dial gauge to the surface of the nut and spindle. Place the pointer on the rim surface as illustrated (**Figure 16**).
7. Grasp the wheel assembly at the three o'clock and nine o'clock positions. Oscillate the hub a maximum of five degrees several times while pushing inward on the hub. Zero the dial indicator. Oscillate the hub a maximum of five degrees several times while pulling outward on the hub, record the end play shown on the dial gauge (**Figure 16**).

NOTE: If a recorded wheel end play of more than .005" (0.127 mm) while alternating ± 50 lbs (220 N) forces is measured, the hub unit MUST be replaced.

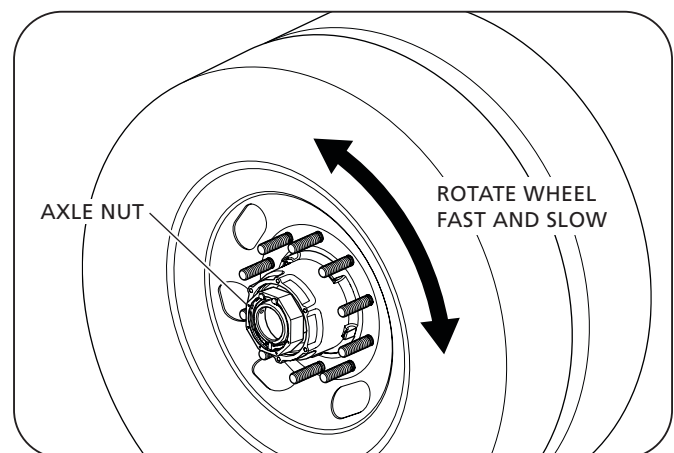
Figure 19

5. Rotate the wheel in both forward and rearward directions, using varying speeds (**Figure 19**).
6. If the bearing feels rough and/or a "grinding" noise is heard, the hub MUST be replaced.

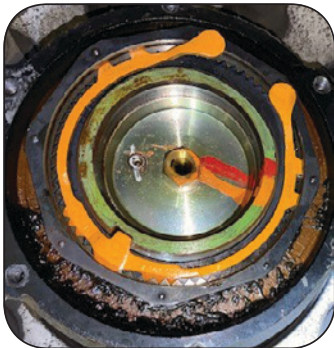
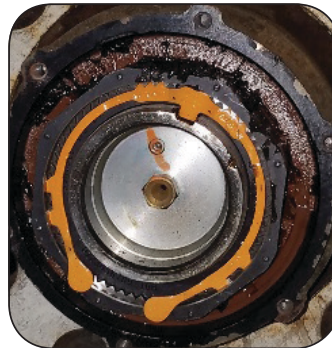
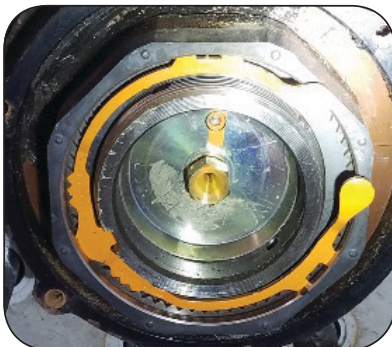
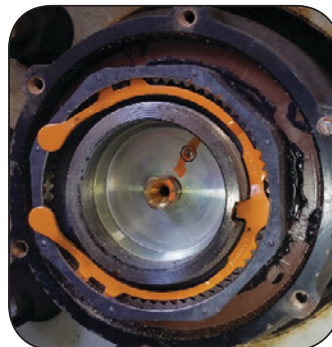
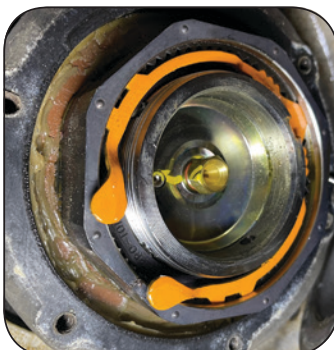
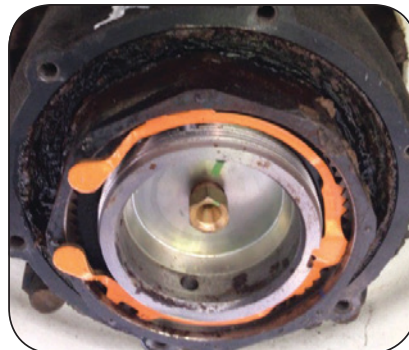
Examples of Bearing Seepage

1. The P89 Plus bearing package is designed to allow for some seepage/leakage of grease from the sealed cartridge bearing. This is a result of the hydraulic action of the bearing working the grease. The following figures (**Figures 20 through 25**) will describe typical seepage you may see.
2. The grease on the face of the bearing will appear black in color. This is normal and a result of the grease getting properly worked in the bearing.
3. During the initial break in period a small amount of clear/ opaque grease may be visible. This is normal and does not indicate a leak.
4. If you have questions about this criteria you may contact your local Field Service Rep or SAF-HOLLAND Warranty at 800-396-6501.

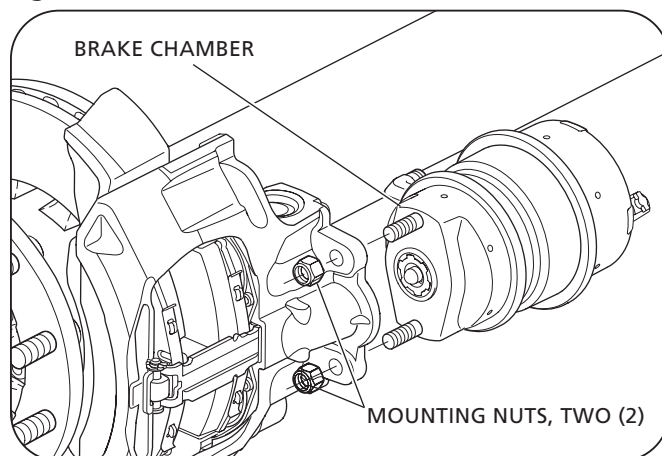
Figure 26

1. Cage the spring brake.
2. Remove the ABS sensor by following the instructions detailed in Section 11.1.
3. Remove the brake chamber from the brake caliper by loosening and removing the two (2) mounting nuts (**Figure 26**).

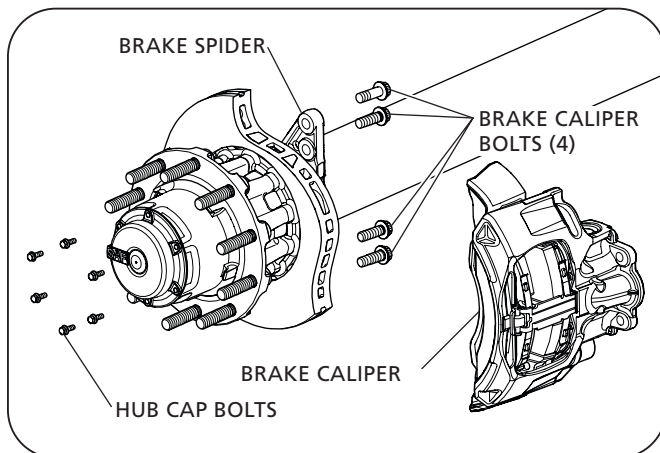
Figure 27

4. Remove the brake caliper from the brake spider by using a size 24 mm socket to loosen and discard all four (4) brake caliper bolts (**Figure 27**).
5. With a 1/2" socket, remove the six (6) hub cap bolts and the hub cap (**Figure 27**).
6. Utilizing a screwdriver, carefully pry the orange keeper arm from the undercut groove on each side of the one piece axle nut until the keeper is released from it (**Figure 28**).
7. Using a standard 4-13/16" P-Spindle wheel nut socket, remove the spindle nut by rotating it in a counter-clockwise direction (**Figure 28**).
8. Remove the head unit by gently sliding it off the spindle. (**Figure 29**).
9. Remove the bearing spindle seal from the spindle and discard (**Figure 30**).

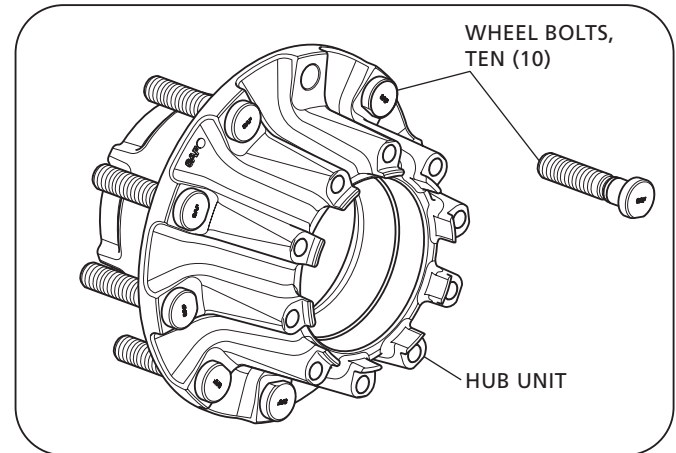
Figure 31

1. Remove the wheel bolts by pressing them out of the hub unit and discard (**Figure 31**).
2. Install new wheel bolts by pressing them into the hub unit. To ensure correct alignment of the bolts during installation, position the flat side of each wheel bolt head so that it is facing the center of the hub (**Figure 32**).

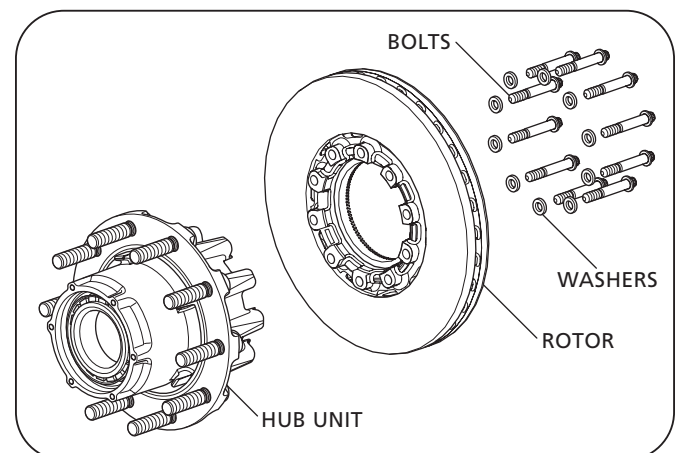
Figure 33

1. Remove the hub unit from the rotor by using a size 15 mm socket to loosen and discard all ten (10) connection bolts (**Figure 33**).
2. Clean the rotor contact surface on the hub. Using compressed air, clean the tapped holes in the hub. Check to make sure the threads are undamaged.
3. Attach the new rotor to the hub using ten (10) new SAF specific INTEGRAL bolts and washers (**Figure 33**). Using a torque wrench, pre-torque the bolts to 40 ft.-lbs. (54 N•m). For final torque, tighten the bolts to 140 ft.-lbs. (190 N•m) using a crisscross pattern. Refer to the Torque Chart in Section 12 for more information.

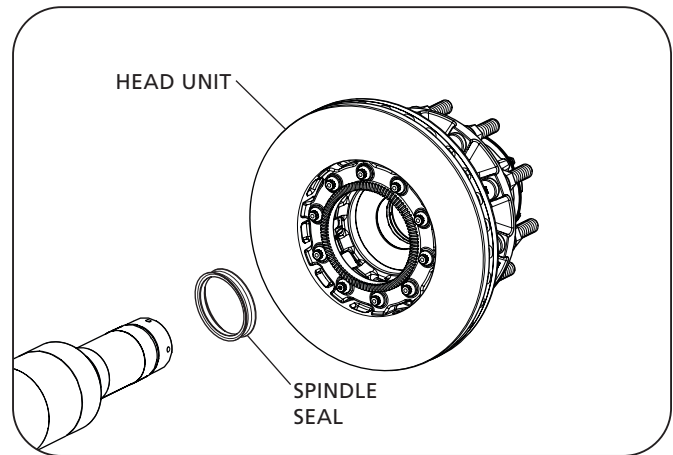
Figure 34

2. Coat a new spindle seal with SAF-HOLLAND fitting paste 05387004203 and slide it onto the spindle (**Figure 34 and 35**).
3. Re-install the head unit by gently sliding it on the spindle (**Figure 34**). Take care to orient the seal correctly (**Figure 35**).

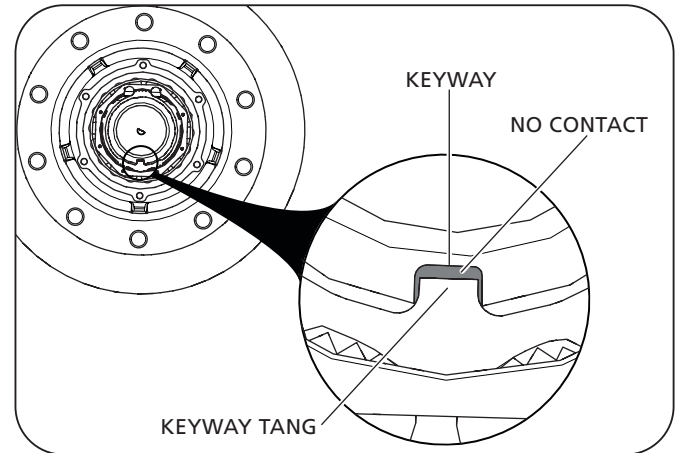
Figure 37

8. Engage the mating teeth (**Figure 37**).
9. Compress and insert the keeper arms, one at a time, into the undercut groove with a screwdriver.
10. If the keeper teeth do not line up with the teeth in the nut, tighten the nut slightly until they engage. DO NOT loosen the nut to align the teeth.

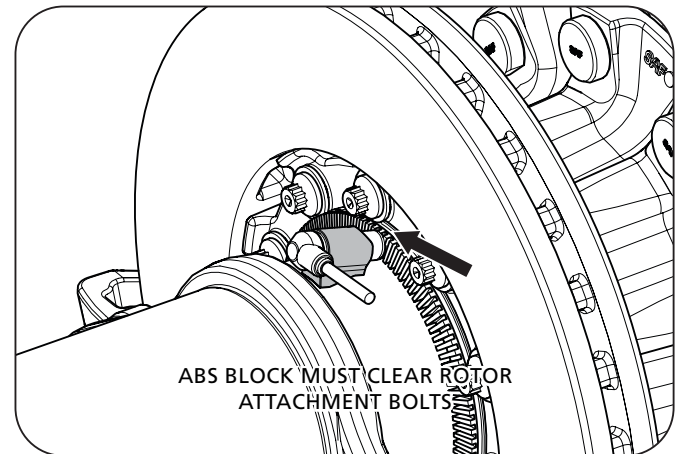
Figure 38

When installing new washers, the attachment bolts can interfere with the ABS sensor block. Ensure that there is clearance provided for ABS Sensor Block (**Figure 38**). Failure to provide clearance can cause damage to property. Refer to service bulletin XL-SA20031SB-en-US.

When installing new washers, the attachment bolts can interfere with the ABS sensor block. Ensure that there is clearance provided for ABS Sensor Block (**Figure 38**). Failure to provide clearance can cause damage to property. Refer to service bulletin XL-SA20031SB-en-US for ABS Sensor Block Modification Procedure.

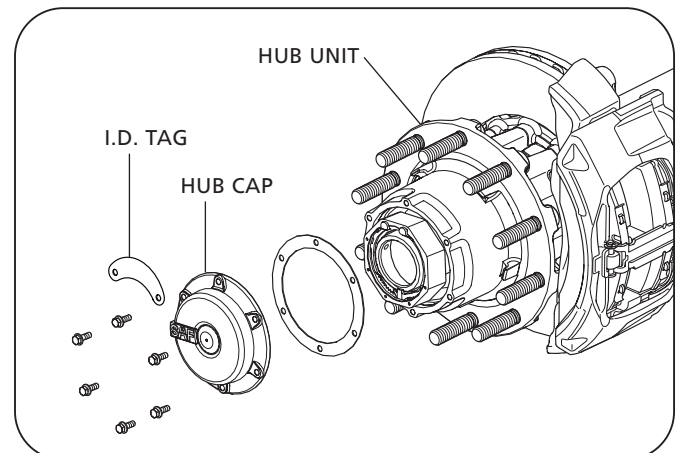
Figure 39

15. Install the six (6) bolts to secure the hub cap assembly (**Figure 39**). Tighten bolts to 12-16 ft-lbs (16 N•m).

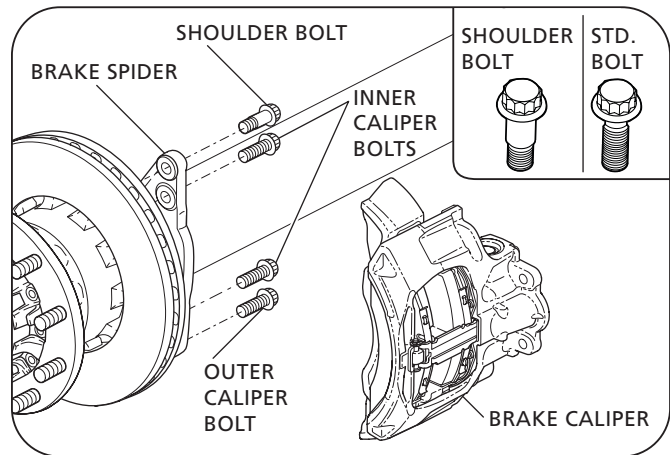
Figure 40

1. Re-install the caliper onto the brake spider using four (4) new SAF specific brake caliper bolts (**Figure 40**):
 - a. Pre-torque the bolts to 88 ft.-lbs. (120 N•m) starting with the shoulder bolt and work across the spider using a size 24 mm socket.
 - b. Verify the pre-torque of the bolts a second time, and if necessary re-tighten all bolts to 88 ft.-lbs. (120 N•m).
 - c. Final torque to 331 ± 22 ft.-lbs. (450 ± 30 N•m), starting with the shoulder bolt and work across the spider the spider.

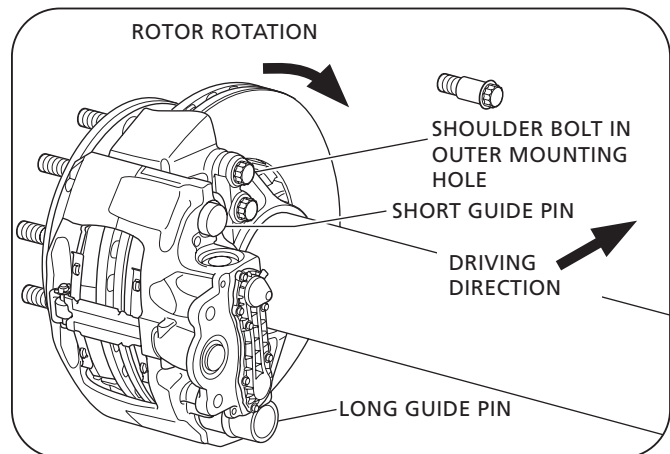
Figure 41

IMPORTANT: Make sure that the brake caliper is mounted on the correct side of the axle. The correct position can be identified by the lengths of the guide pins on the caliper unit. The longer guide pins should be positioned on the bottom of the caliper unit when installed rearward of the axle and on top when forward of the axle (**Figures 41 and 42**).

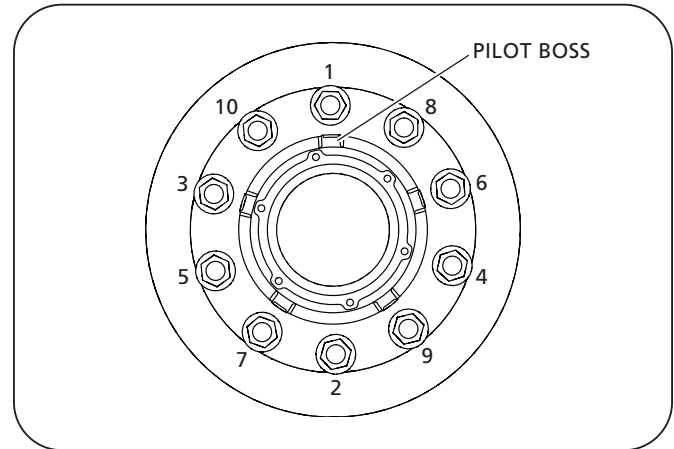
Figure 43

1. Clean all mating surfaces on hub, wheels and nuts.
2. Rotate the hub so a pilot boss is at the top (12 o'clock) position (**Figure 43**).
3. Mount wheel(s) on hub. One or more of the wheel nuts can be started in order to hold wheel in position.
4. Tighten the top wheel nut first. Apply 50 ft-lbs (68 N•m) of torque to draw the wheel up fully against the hub.
5. Install remaining wheel nuts. Using sequence shown in (**Figure 43**), tighten all wheel nuts to 50 ft-lbs (68 N•m) of torque.
6. Repeating sequence shown in (**Figure 43**), retighten all wheel nuts to 475 ± 25 ft. lbs. (644 ± 34 N•m) of torque.
7. Check seating of wheel at the pilot bosses. Rotate wheel and check for any rotational irregularity.

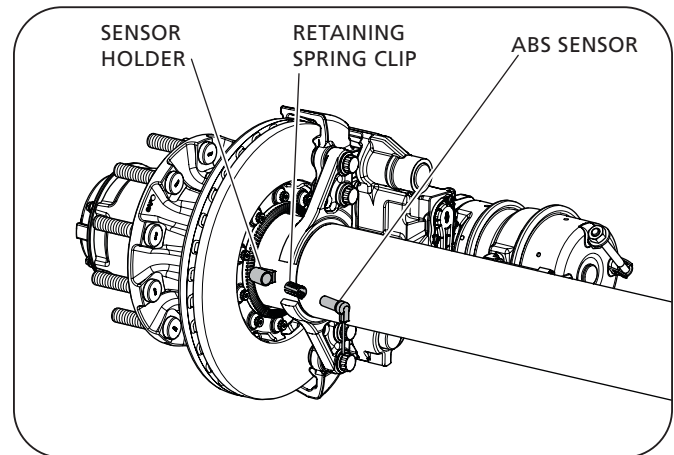
Figure 44

1. Disconnect the ABS sensor.
2. Remove the ABS sensor from the sensor holder by pulling it straight out from the holder and discard (**Figure 44**).
3. If necessary, remove the sensor retaining spring clip from the sensor holder and replace with new clip. (**Figure 44**).
4. Install a new ABS sensor by pushing it directly into the sensor holder/spring clip until it contacts the tooth wheel in the hub unit (**Figure 44**).

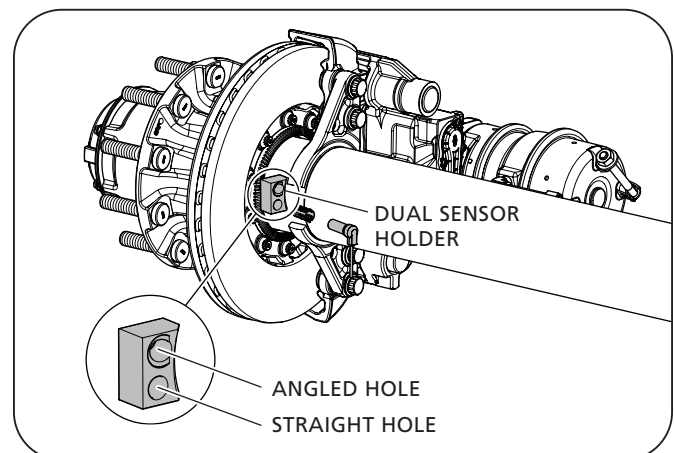
Figure 45

NOTE: Some models will have a dual ABS sensor Block (**Figure 45**). Be sure to use the angled hole for ABS sensor.

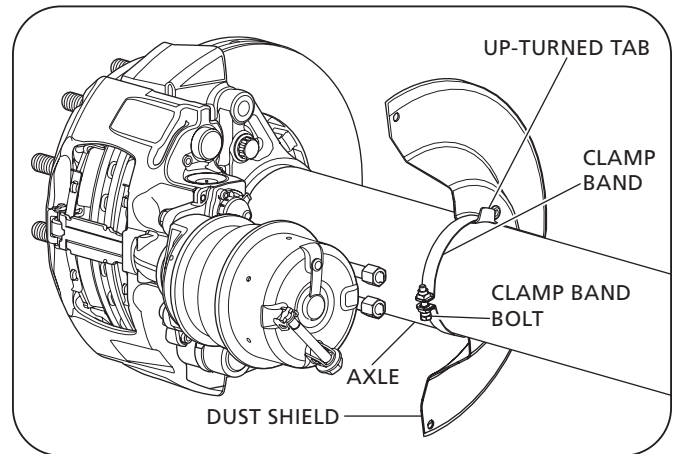
Figure 46

Refer to **Figure 46** for the following instructions:

1. Using a 13 mm socket, loosen and remove the dust shield clamp band bolt.
2. Route any ABS sensor wires through one of the two rubber grommets on the dust shield and position the dust shield on the axle.
3. Wrap the clamp band around the axle and dust shield and loosely install the clamp band bolt.
4. Slide the dust shield and clamp band together toward the disc brake until the clamp band is about 12 mm (0.5") from the brake rotor, pulling the ABS sensor wire through the rubber grommet as necessary.
5. Torque the clamp band bolt to 20-25 ft-lbs (27-34 N•m).
6. Use a pry bar and/or rubber mallet to ensure that there is clearance between the dust shield and the rotor.
7. Plug the ABS sensor into the abs system wire.
