Service Bulletin

ADLSD Suspensions

ADLSD Shim and Spacer Installation, Bushing Inspection and Equalizing Blade Wear

May 2017

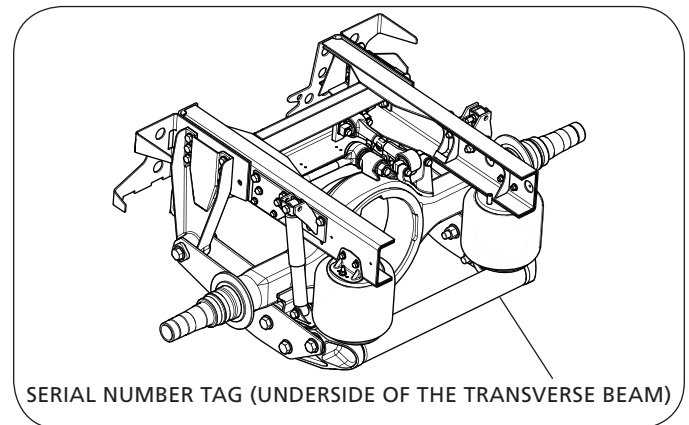
Figure 1

The serial tag is found on the underside of the transverse beam (**Figure 1**). The serial tag contains important suspension information including the part number (**Figure 2**). The affected part numbers are as follows:

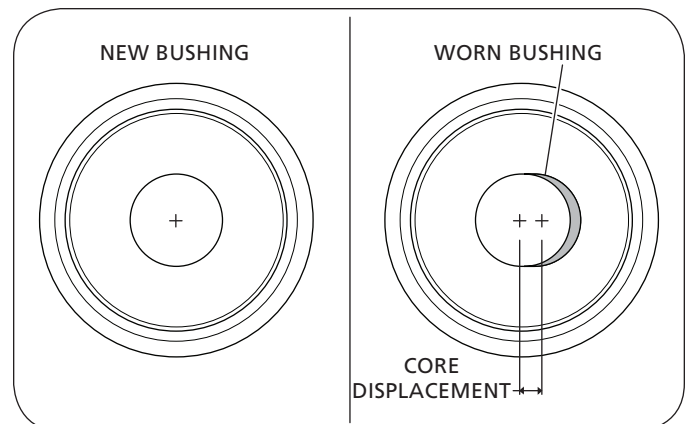
Figure 3

Suspension bushing inspection is required during regularly scheduled preventative maintenance. If any of the pivot, axle adapter, or transverse beam bushings appear to be worn showing permanent core displacement it is recommended to replace the bushings. The allowable radial bushing core displacement is 0.20" (5.0 mm) (**Figure 3**). The service kit shown on Page 6 was created for Gillig ADLSD bushing replacement.

IMPORTANT: The use of oil-based lubricants, brake fluid or never-seez[®] will lead to degradation of bushing rubber resulting in accelerated wear out or separation from core. SAF-HOLLAND recommends International Products P80 or similar "rubber friendly" products to aid in bushing insertion.

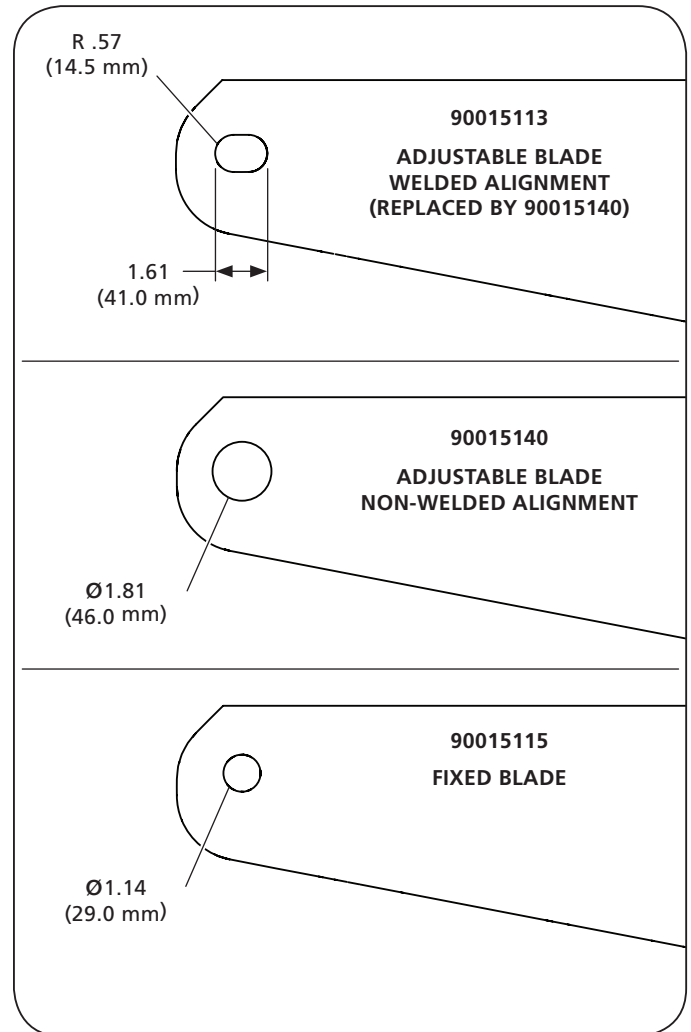
Figure 5

During a regularly scheduled preventative maintenance inspection, inspect the equalizing beam blades for wear at all connection points. Some surface wear is acceptable and is only considered excessive if the wear is deeper than .06" (1.6 mm) from the normal surface. If the wear is deemed excessive, equalizing beam blade replacement is recommended. Determine the equalizing beam type (fixed or adjustable) to determine which service kit to use (**Figure 5**).

The following replacement instructions are to be used in conjunction with XL-AK400-01 to ensure safety.

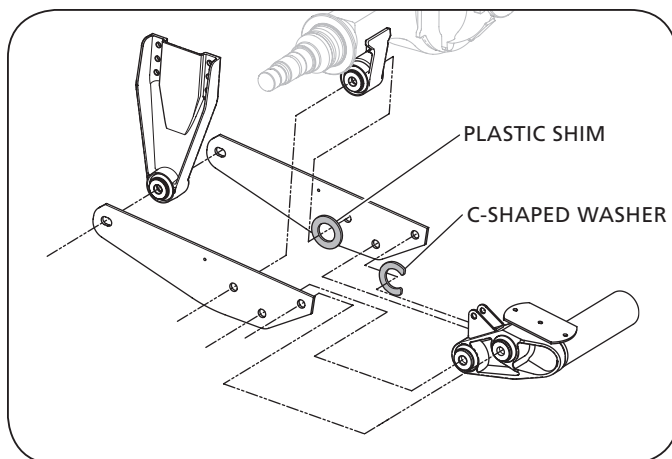
Figure 4 shows the correct placement for both the C-Shaped washer and the plastic shim.

IMPORTANT: The use of additional washers or shims in any other locations than shown will restrict the suspension movement which could lead to blade failure.

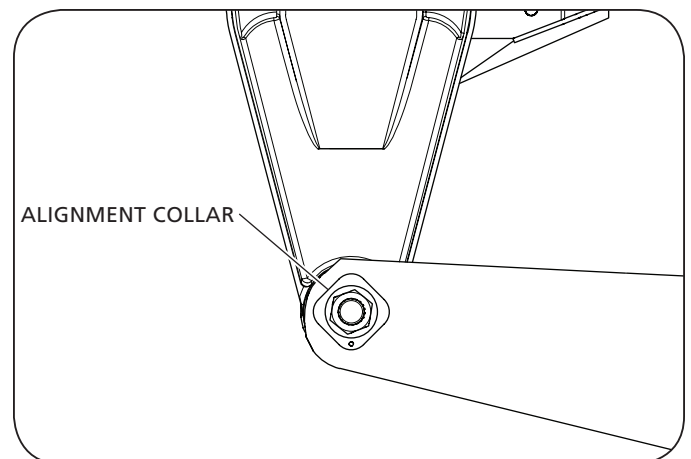
Figure 6

NOTE: If your suspension has a welded alignment, the replacement will be a non-welded alignment style blades and include an alignment collar (**Figure 6**). Service kits shown on pages 4 and 5 were created for Gillig ADLSD blade replacement.

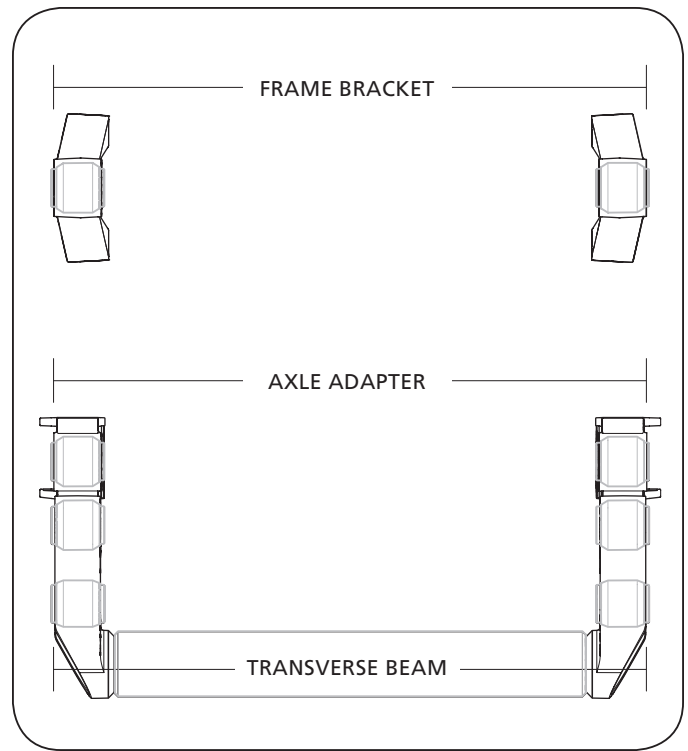
Figure 7

Prior to replacing equalizing beam blades, measure all connection points as illustrated (**Figure 7**).

IMPORTANT: Measurement should not include bushing core offset and should be outside widths of castings as close to bushing receptacle edges as possible.

If the axle adapter is greater than .25" (6.4 mm) wider than other attachment points a bushing shim kit is required. Refer to Page 7 for bushing shim service kit and shim location.

NOTE: The purpose of the shim is to get the frame bracket, axle adapter and transverse beam connections within .25" (6.4 mm) or less measured across their widths.

Bushing shims are to be clamped between bushing core and equalizing beam blades.

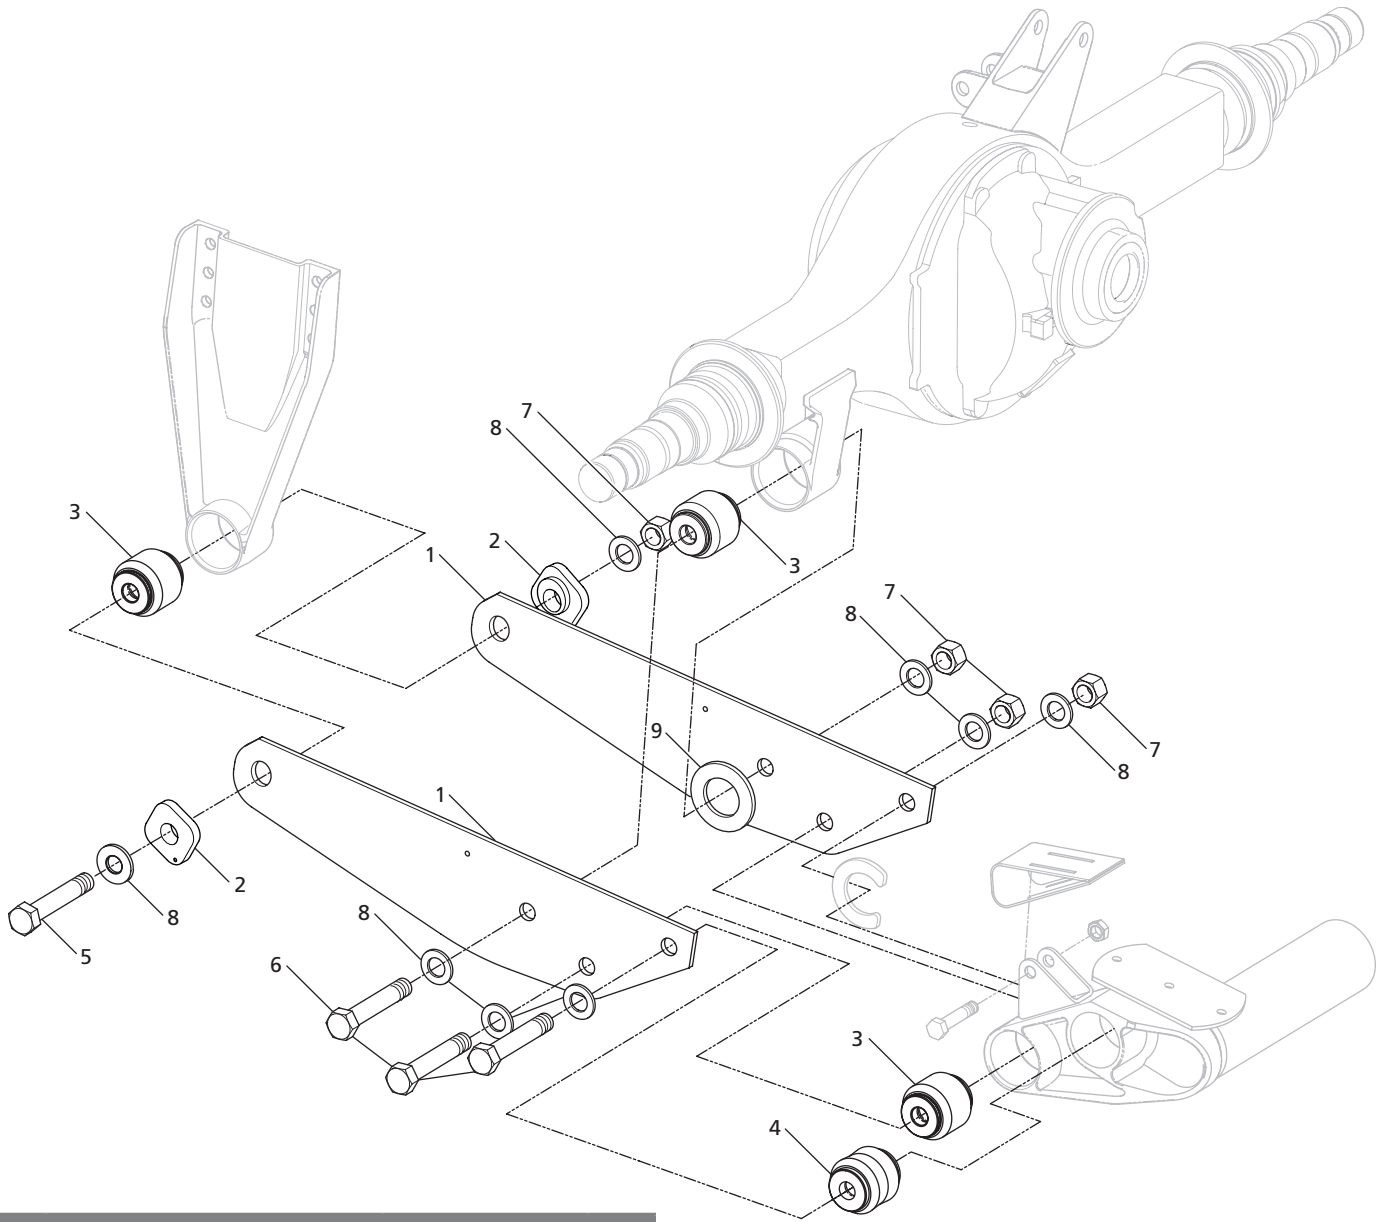
ADJUSTABLE BEAM: 48100665, SRK-799			
ITEM	DESCRIPTION	PART NUMBER	QTY.
1	Beam, Equalizing – ADJ	90015140	2
2	Block, Alignment	90008268	2
3	Bushing	90008191	3
4	Bushing	90008241	1
5	Bolt, Hex – 1.13-7 x 7.5 GR 8	93004541	1
6	Bolt, Hex – 1.13-7 x 7 GR 8	93004529	3
7	Nut, Hex – 1.13-7 GR C	93400506	4
8	Washer, Flat – 1.13 Narrow	93600174	8
9	Shim, Pivot	90036268	1
10	Service Bulletin (Not Shown)	XL-AS200735B-en-US	1

NOTE: This kit services one side of the suspension ONLY.

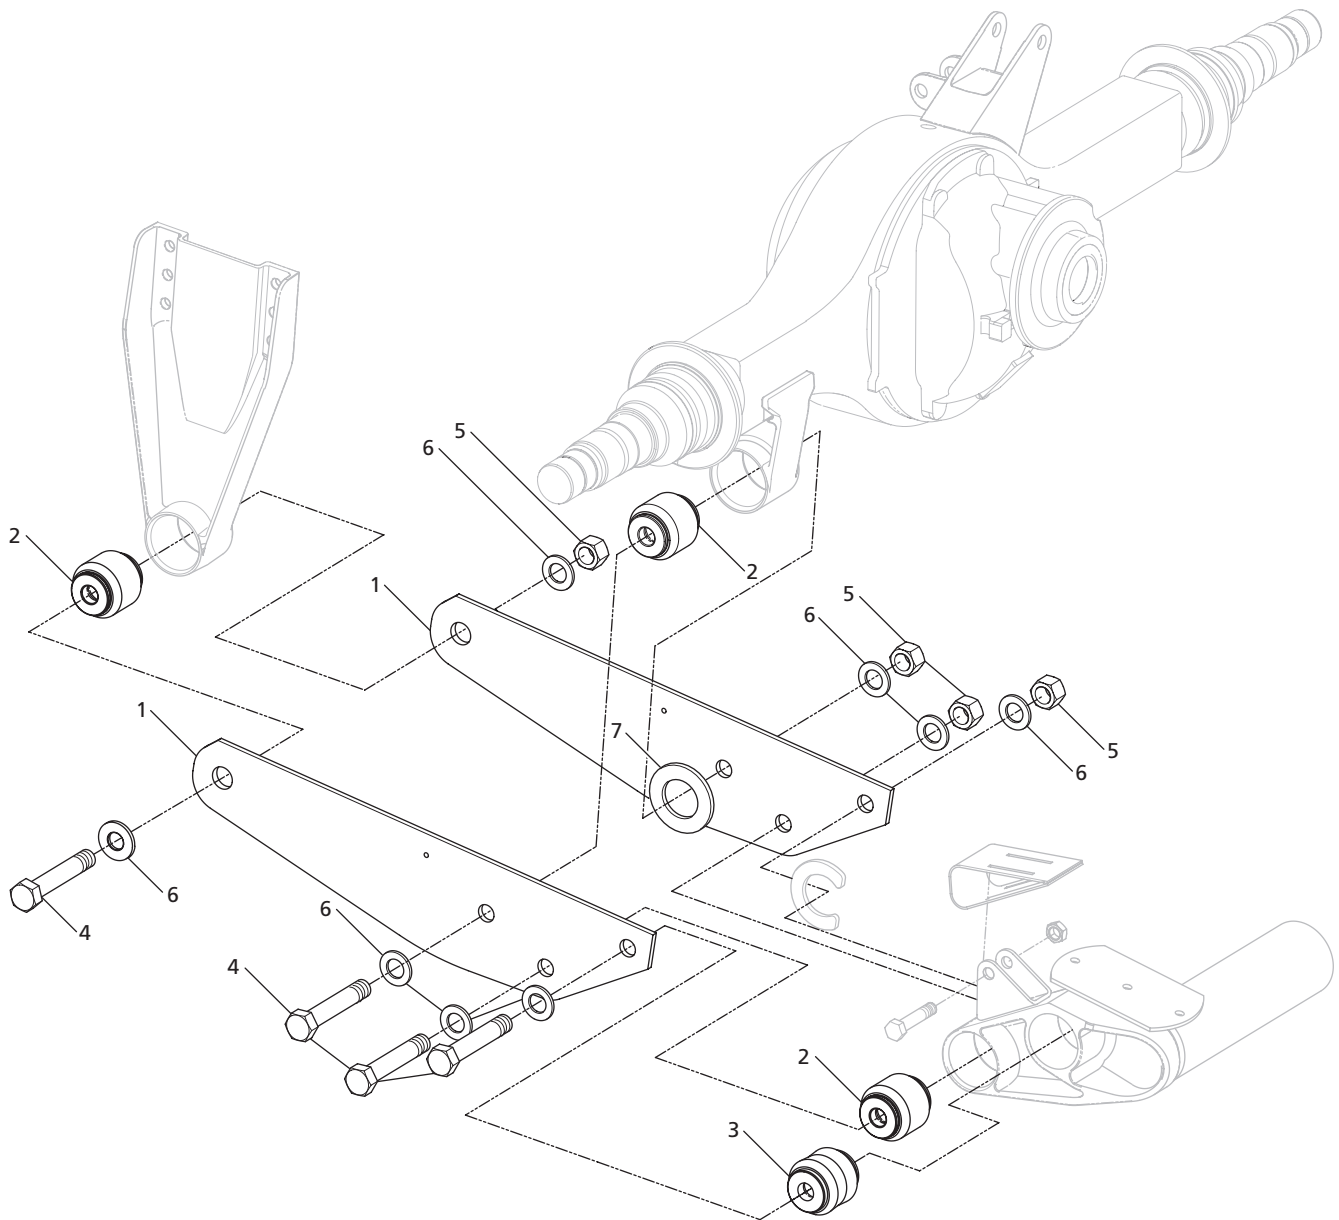
FIXED BEAM: 48100666, SRK-800			
ITEM	DESCRIPTION	PART NUMBER	QTY.
1	Beam, Equalizing – FIXED	90015115	2
2	Bushing	90008191	3
3	Bushing	90008241	1
4	Bolt, Hex – 1.13-7 x 7 GR 8	93004529	4
5	Nut, Hex – 1.13-7 GR C	93400506	4
6	Washer, Flat – 1.13 Narrow	93600174	8
7	Shim, Pivot	90036268	1
8	Service Bulletin (Not Shown)	XL-AS200735B-en-US	1

NOTE: This kit services one side of the suspension ONLY.

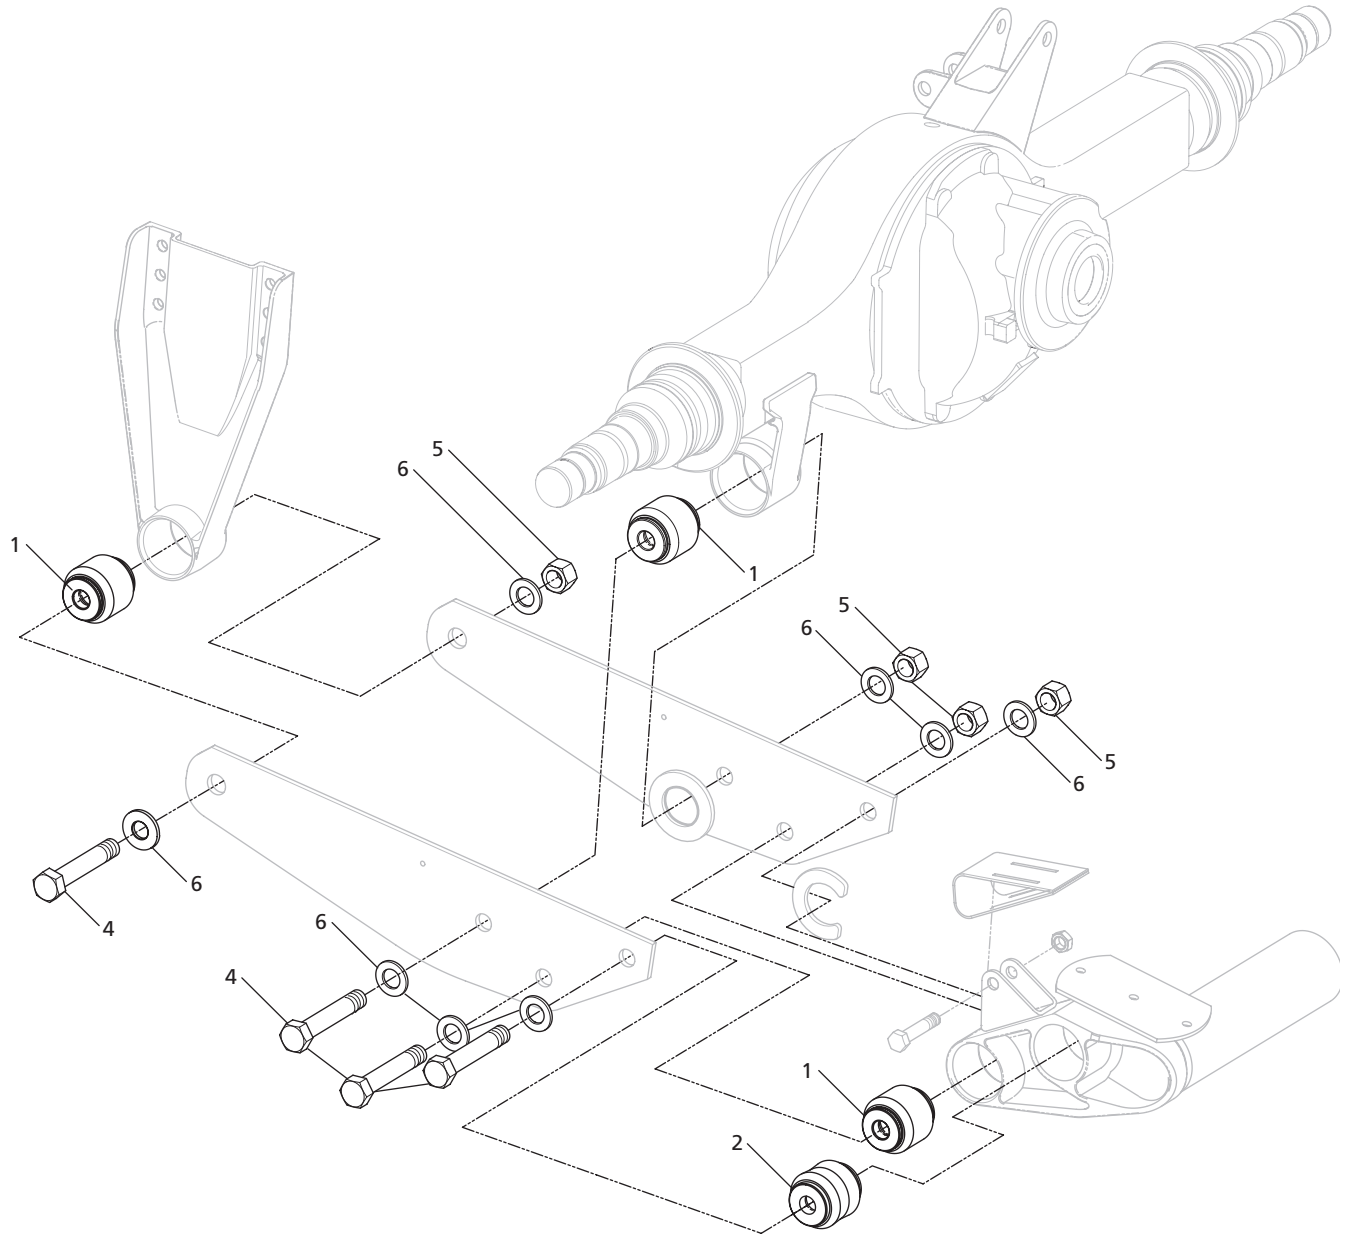
BUSHING KIT: 48100667, SRK-801			
ITEM	DESCRIPTION	PART NUMBER	QTY.
1	Bushing	90008191	6
2	Bushing	90008241	2
3	Bolt, Hex – 1.13-7 x 7.5 GR 8	93004541	1
4	Bolt, Hex – 1.13-7 x 7 GR 8	93004529	7
5	Nut, Hex – 1.13-7 GR C	93400506	8
6	Washer, Flat – 1.13 Narrow	93600174	16
7	Service Bulletin (Not Shown)	XL-AS20073SB-en-US	1

NOTE: This kit services BOTH sides of the suspension.

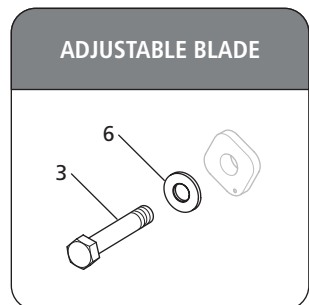
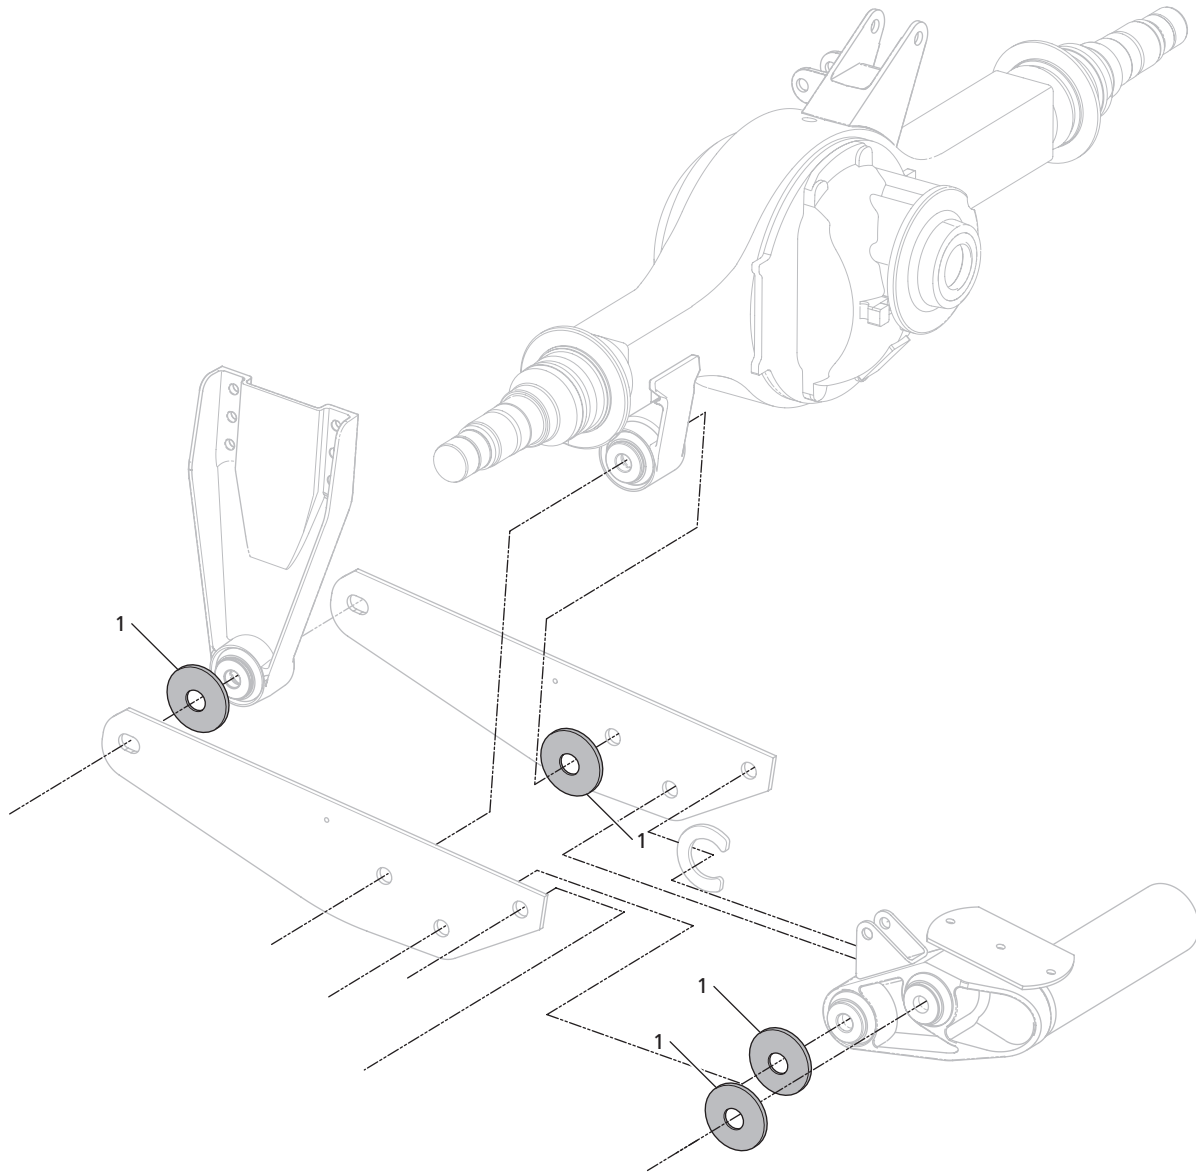
BUSHING SHIM KIT: 48100668, SRK-802

ITEM	DESCRIPTION	PART NUMBER	QTY.
1	Spacer, Bushing	90036309	8
2	Service Bulletin (Not Shown)	XL-AS20073SB-en-US	1

NOTE: This kit services BOTH sides of the suspension.
