Service Bulletin

5.75" Diameter Trailer Axles With P89® Integral Disc Brakes

ABS Sensor Block Replacement

October 2016

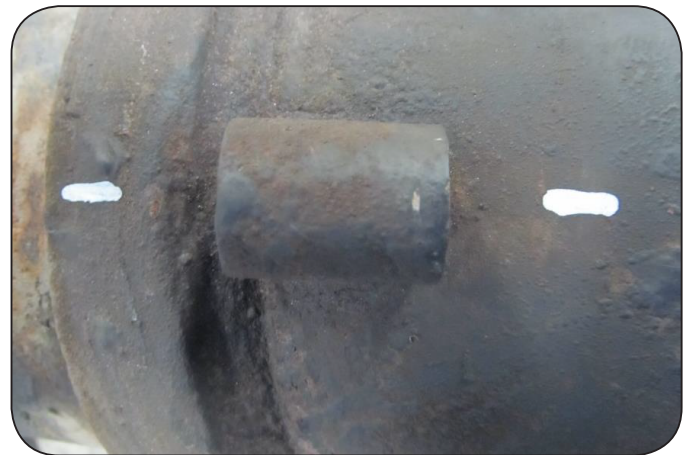
Figure 1

4. Clearly mark the centerline of the damaged ABS sensor block on the Axle (**Figure 1**).

IMPORTANT: These marks are needed in step 6 to properly position the replacement ABS sensor block.

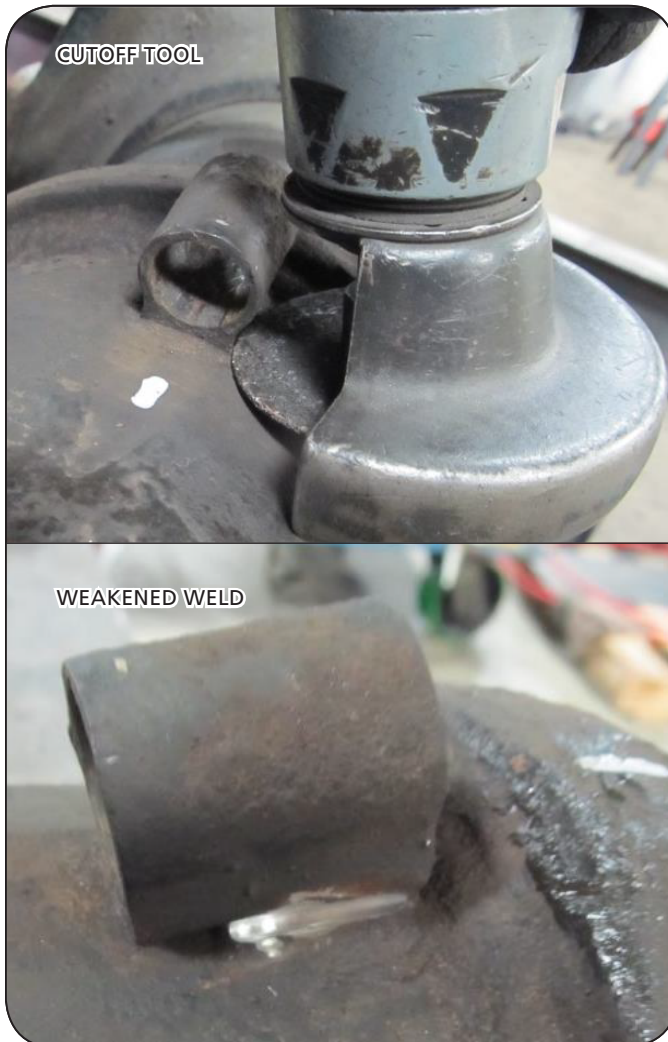
Figure 2

- Remove the damaged ABS sensor block using a suitable abrasive cutoff tool and/or an air chisel (**Figure 2**).

IMPORTANT: DO NOT use an oxi-acetylene torch.
DO NOT cut into the axle body.
DO use an appropriate sized abrasive cut off tool to weaken one weld (**Figure 2**).

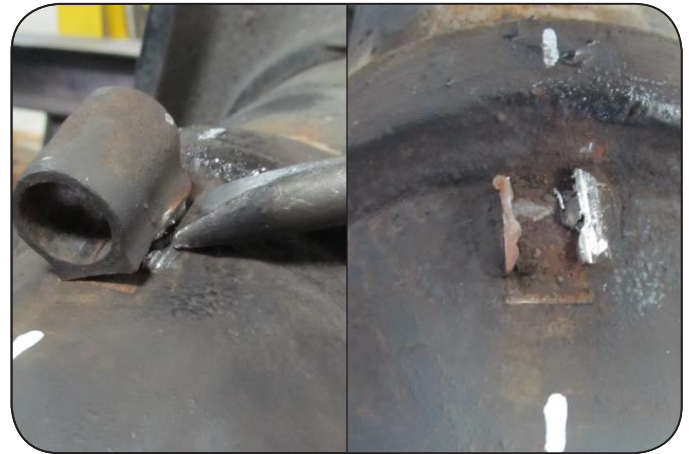
Figure 3

Completely remove the damaged ABS sensor block using an air chisel (**Figure 3**).

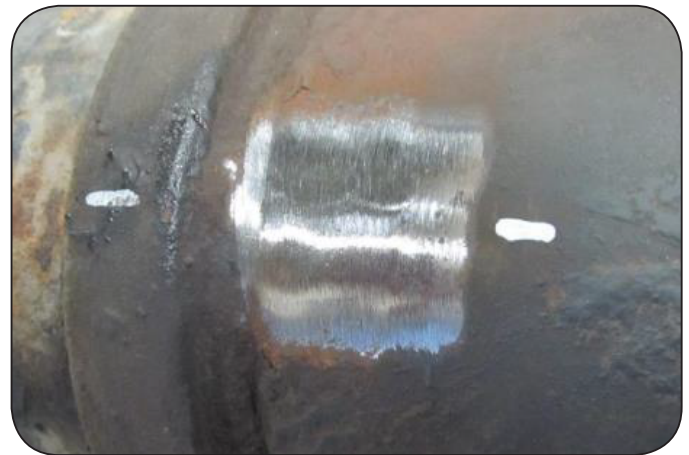
Figure 4

Remove the remainder of the damaged ABS sensor block using a hand grinder with a 60 or coarser grit flexible sanding disc (**Figure 4**).

IMPORTANT: DO NOT remove excessive axle material.

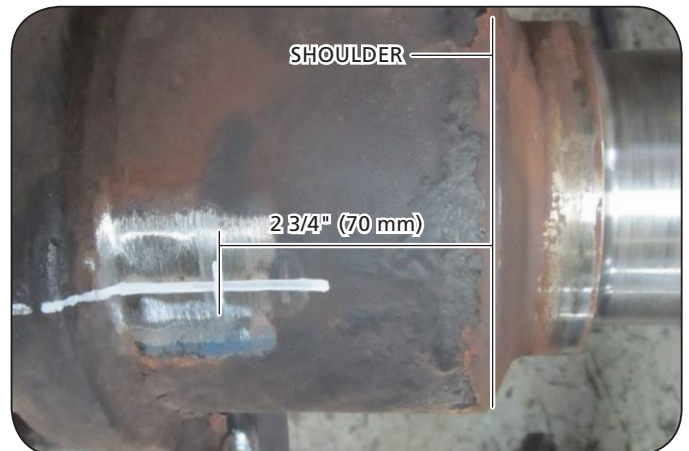
Figure 5

- Connect the ABS sensor block center line marks made in Step 4 above and mark a line $2\frac{3}{4}'' \pm 1/16''$ (70 ± 2 mm) from the spindle shoulder (**Figure 5**).

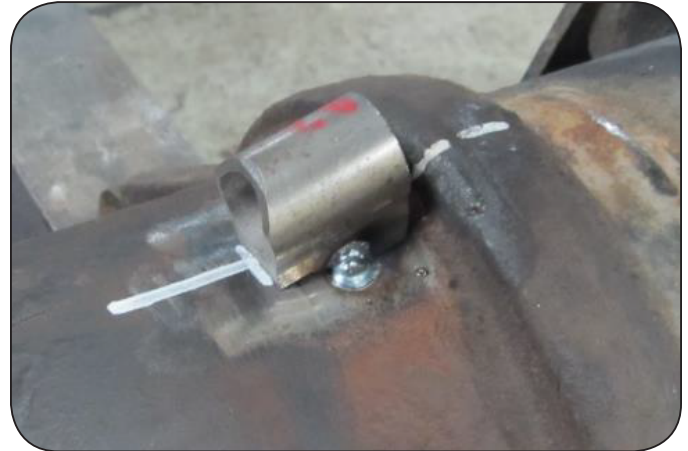
Figure 6

- Center the replacement ABS sensor block on the line marked in step 4 and 6. Line it up with the 2 3/4" (70 mm) mark made in step 6. Using appropriate welding gloves, hold it firmly in place and tack it in place on both sides (**Figure 6**).
- Weld both sides with a 3/16" fillet weld. DO NOT weld around the ends of the ABS sensor block (**Figure 7**).
- Reinstall the head unit on the spindle using the appropriate new spindle seal (01092003100Z for P89, 2024100000120 for P89 Plus (**Figure 8**)), reinstall the wheel end components. Refer to instructions detailed in Section 11 of XL-SA20018UM-en-US for P89, Section 8 of XL-SA20024UM-en-US for P89 Plus.

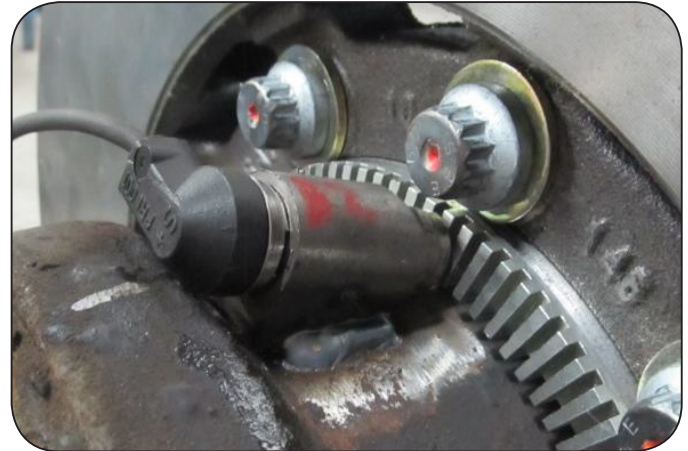
Figure 9

10. Re-Install the ABS sensor and retaining clip (Refer to instructions detailed in Section 16 of XL-SA20018UM-en-US for P89, Section 10 of XL-SA20024UM-en-US for P89 Plus). Rotate the wheel end and ensure there is no interference between the rotor attachment bolts and the ABS sensor block and sensor (**Figure 9**):
11. Reinstall hub cap using new hub cap gasket 01093002300Z, refer to Section 13 of XL-SA20018UM-en-US for P89, Section 8.2 of XL-SA20024UM-en-US for P89 Plus Disc Brake Axle service manuals.
